## AGENDA - Recreation Commission

# PARKS AND RECREATION

# Matthew C. Patterson Park

# Windmill Pointe Park

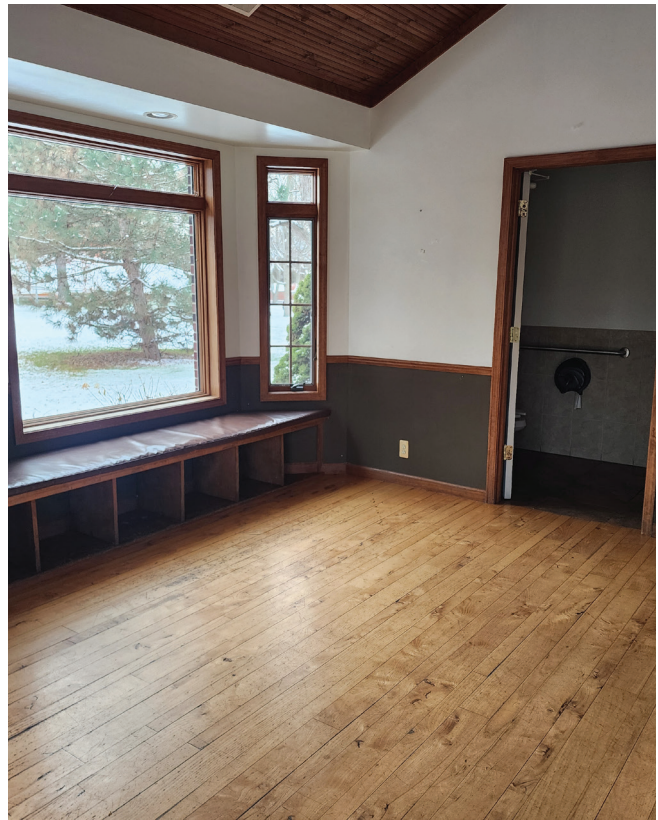
### RESTROOM BUILDING

The restroom building was built in the late 1980's. The year-round facility provides both men's and women's separate restrooms, as well as a storage/mechanical room which houses the pumps for the splash pad. The building is heated but is not cooled.

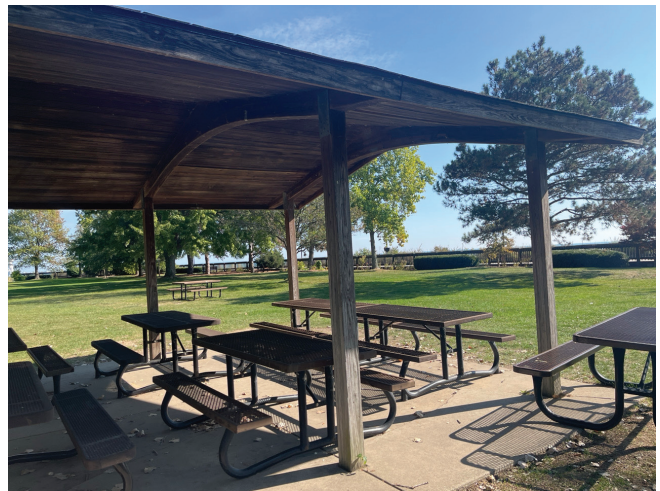
### WILLEKE GAZEBO

The Willeke Gazebo is the only gazebo located in Patterson Park and is in need of repair. Quotes to reconstruct it range between \$10,500 and \$56,000 depending on the level of reconstruction.

The three quotes received from contractors to repair or replace the Willeke Gazebo can be found in the Appendix.

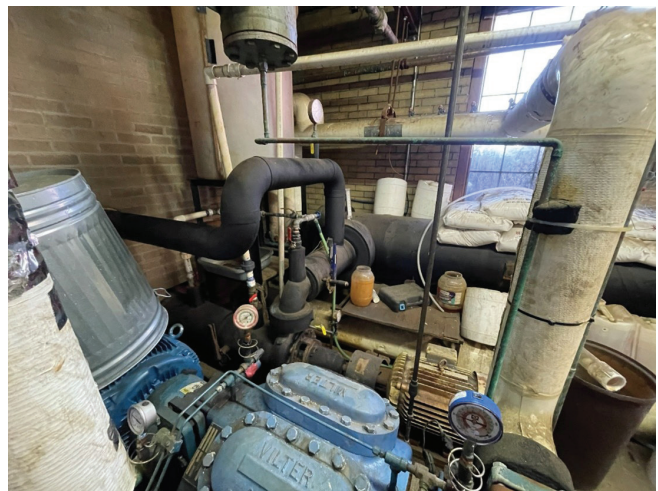
The ice surface for the outdoor rink is managed by a refrigeration system. The majority of the system is housed within the southern bay of the carriage house building. This includes the electrical components and municipal water connections. The system is comprised of 2 compressors, an outdoor chiller and a brine circulation system used to cool the concrete slab beneath the skating surface. The system utilizes R-22 refrigerant which is no longer commonly available.

Brine Circulation System within Carriage House.

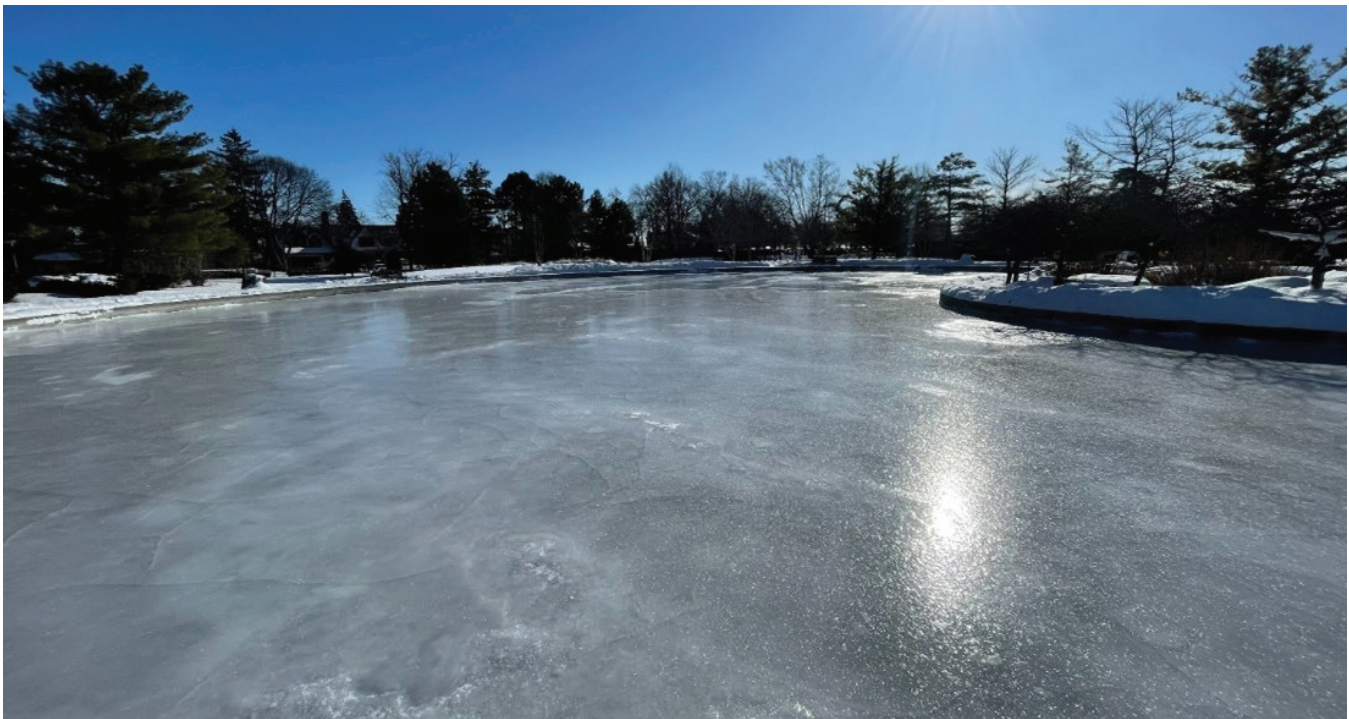
The rink is operated typically during the winter season with ice formation initiated in December after the majority of leaves have fallen from surrounding trees. The ice surface is generally around 1 inch thick and is maintained by park staff. During periods of operation, this maintenance includes initial flooding of the rink, painting of the ice surface (to enhance reflectivity and reduce the impact of sun) and periodic resurfacing to remove snow, ice shavings and debris and flood the surface to fill ruts. In 2025-2026, the City elected to forego the refrigeration system and utilize ambient air temperature to attain ice. This resulted in the use of hose applied water for resurfacing. The City has also utilized one of its 2 resurfacers (commonly known as a Zamboni) on a few occasions to smooth irregularities. After winter operations, the ice rink surface is melted and discharged to the sanitary sewer (due to the white paint applied to the ice surface).

*Ice surface looking south. Image Source: City of Grosse Pointe Park.*

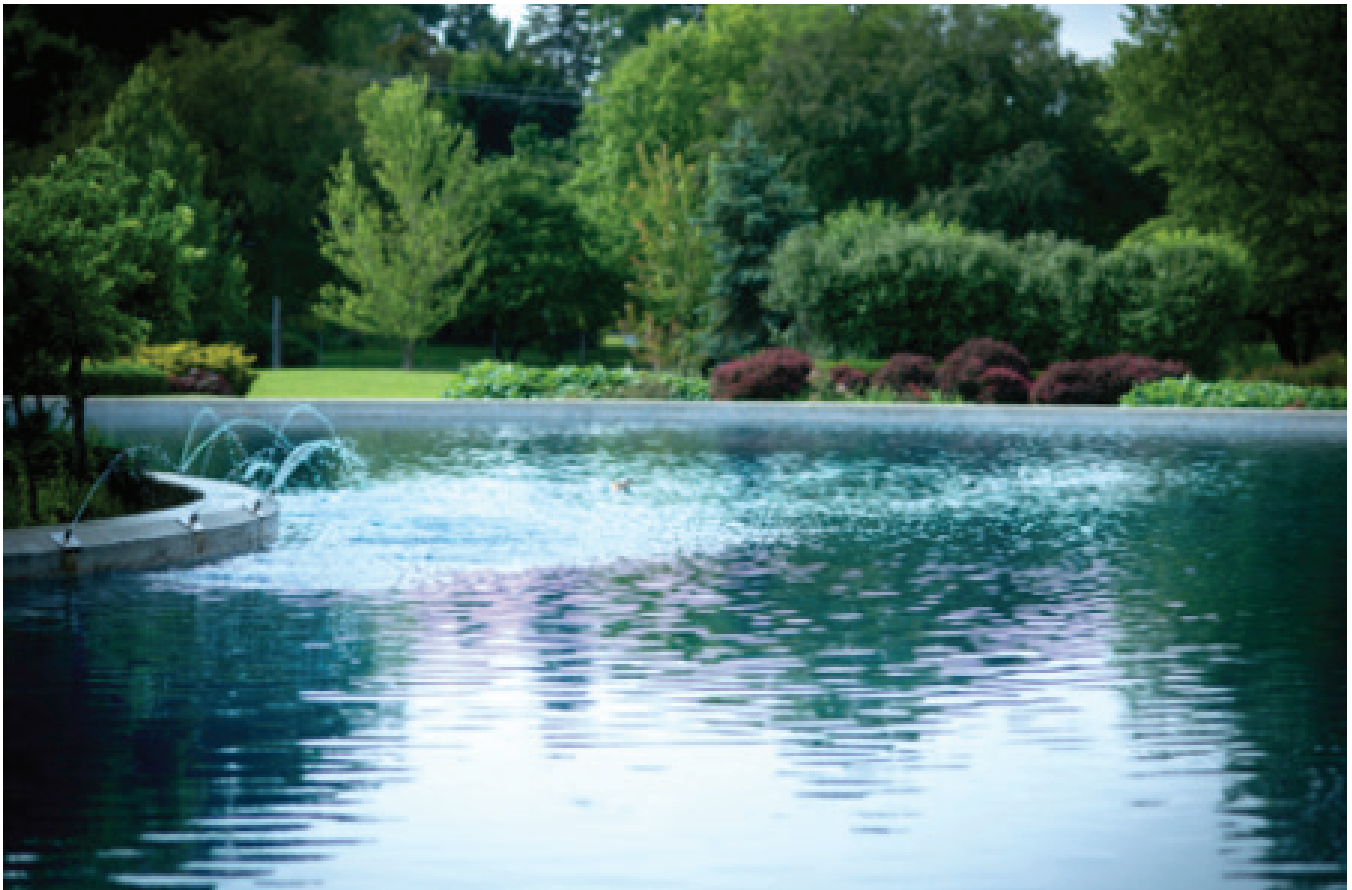
During the spring and summer season, the rink water has been removed, the surface is cleaned of debris. The area is then filled with water from the municipal water supply source. The pool water is kept clear through use of spray heads and a pumped system. Dye is added to the water as well to provide blue color. Additional water is added to the system as needed from the municipal water supply.

*Reflecting Pond. Image Source: City of Grosse Pointe Park.*

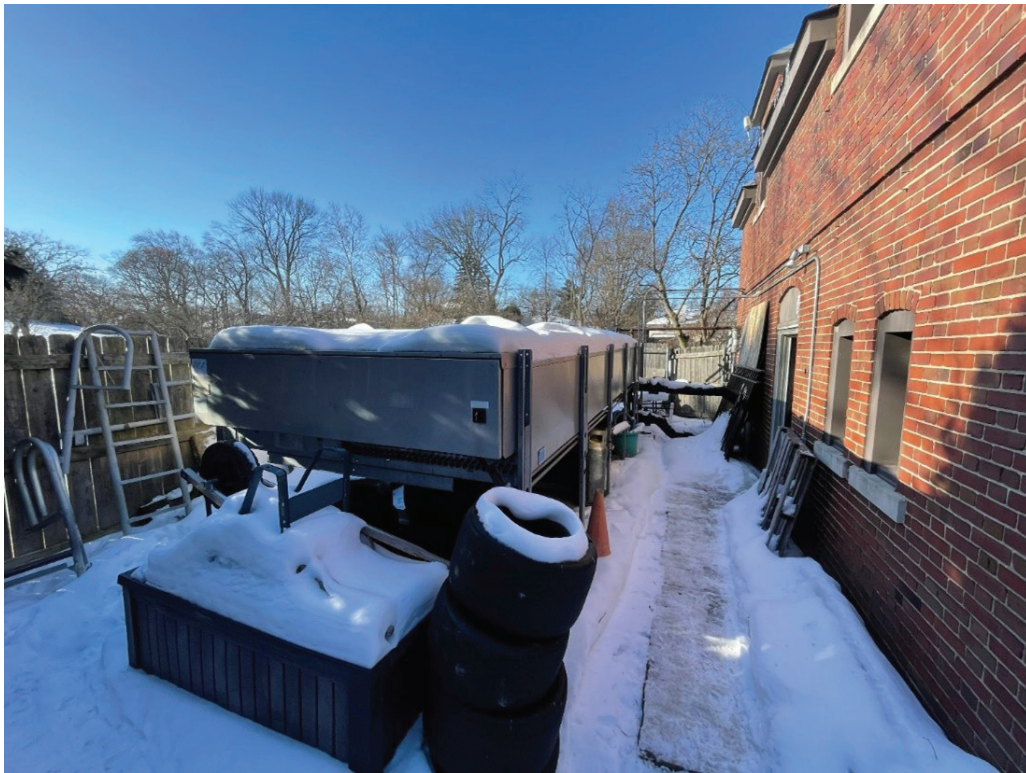
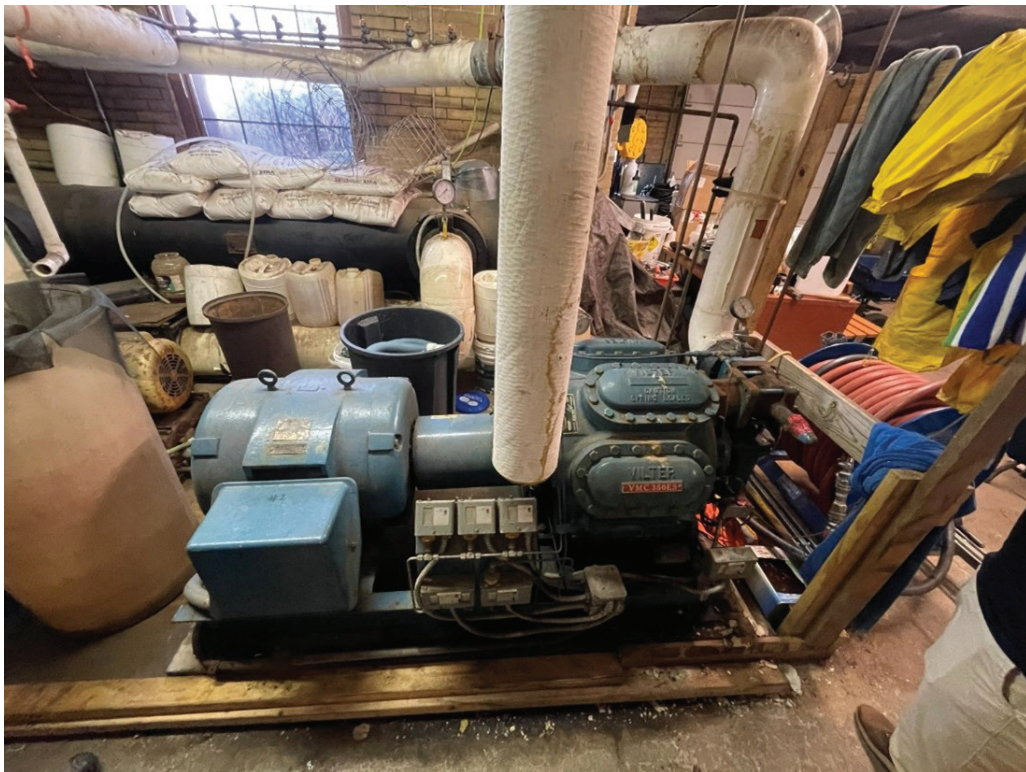
Above: External condenser unit.  
Below: Condenser no. 2 to be replaced.

As part of this effort, the City would replace the existing refrigeration system with a fully new refrigeration utilizing ammonia gas in lieu of freon (note that the existing condenser can likely remain). As a result of the gas, the unit would need to be located outdoors and would likely be placed on the south side of the carriage house. Based on the anticipated noise from the unit, a building of structure capable of dampening and shrouding sound would be necessary. The estimated cost of a new system (excluding structure) is \$800,000.

This alternative includes the replacement of the existing condensers with more modern units. These would be either new Vilter 456XLD compressors and motor or rebuilt VMC 450 ES units. These units would extend the life of the existing system and reduce operating costs through more efficient operation. Viable and rebuilt portions of the existing 350 ES compressors would be salvaged and sold for parts. The cost to install new compressors is roughly \$300,000, while refurbished compressors would cost about \$200,000.

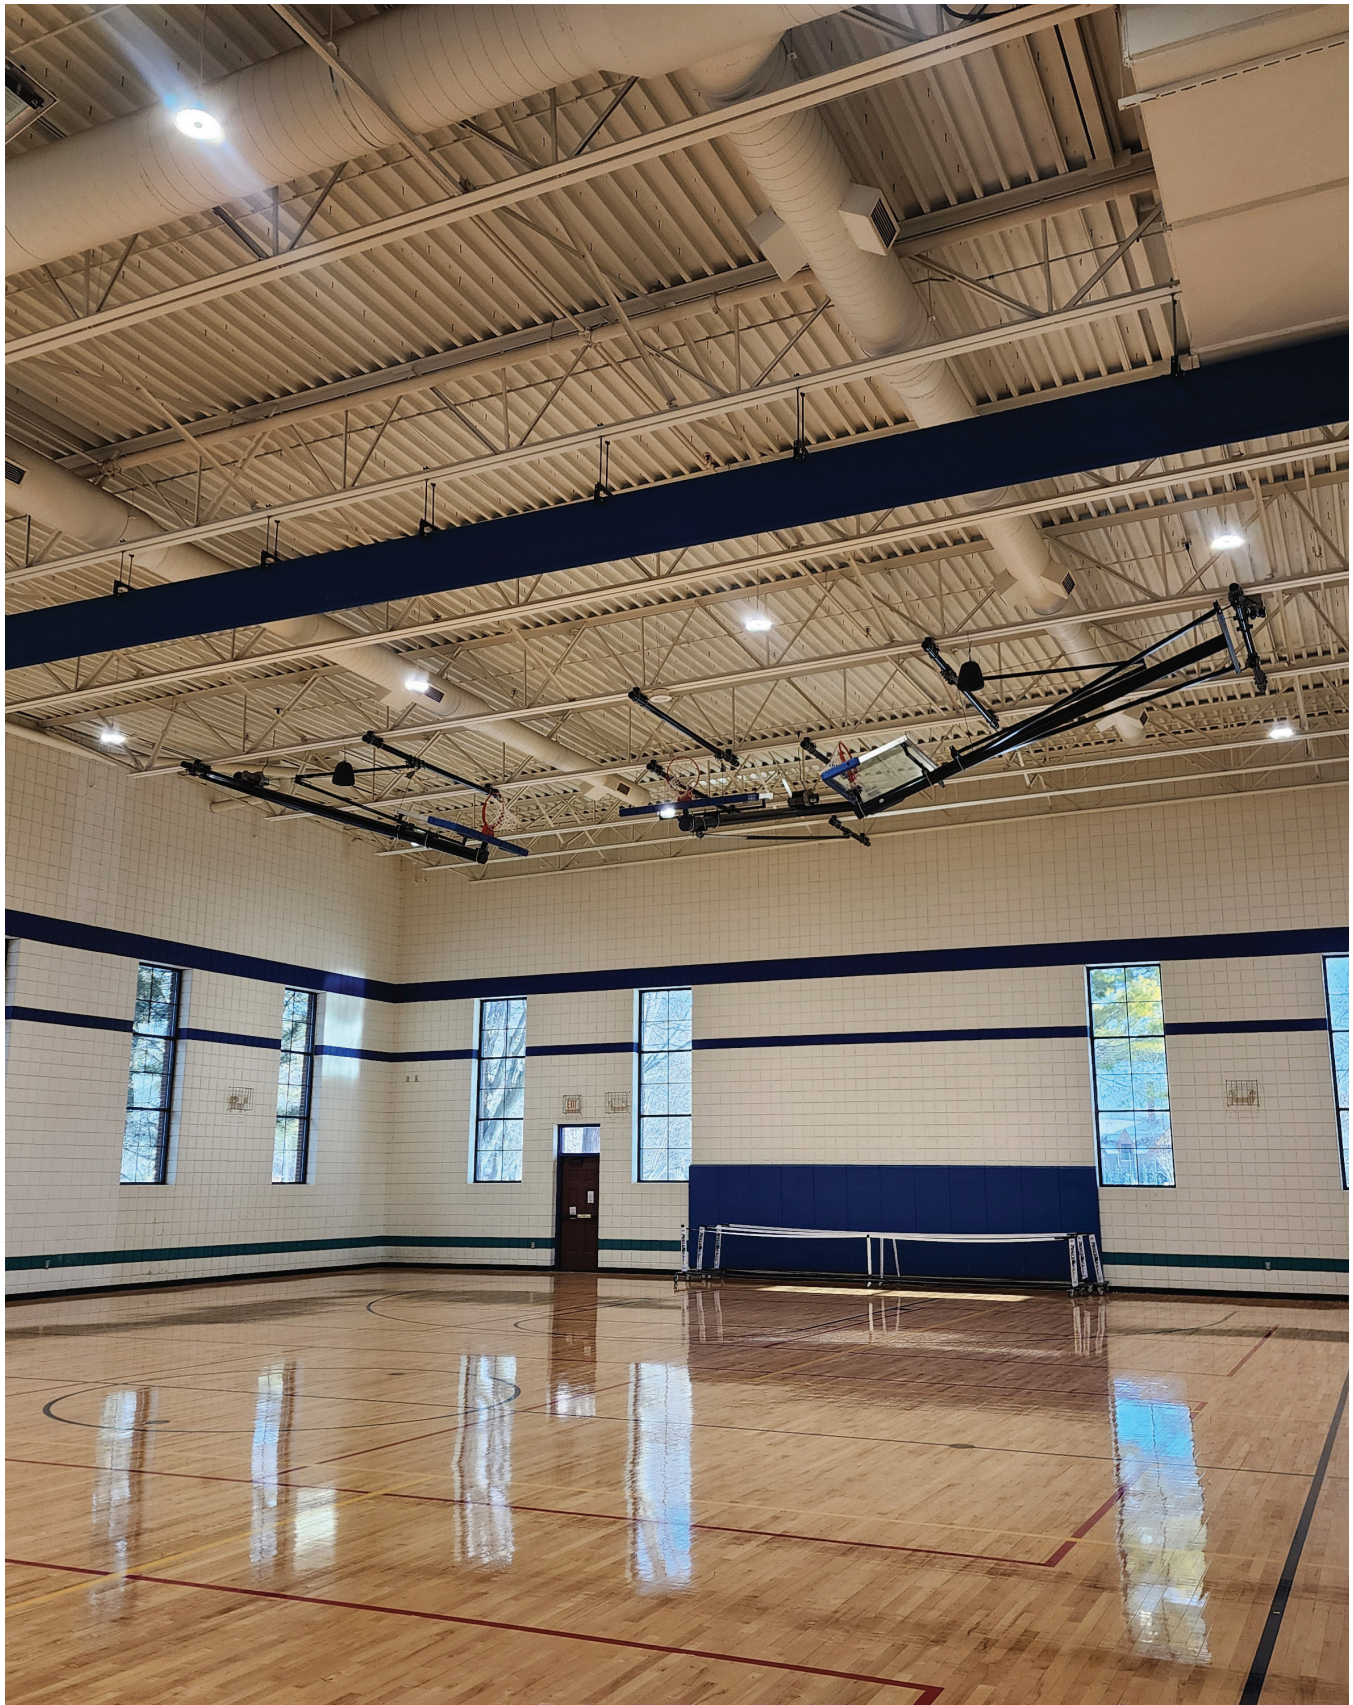
### TOMPKINS COMMUNITY CENTER

The Tompkins Community Center was originally constructed in the late 1930s and has had multiple renovations over the years. The last major renovation was completed in 2018 which included the addition of a lake facing sunroom and renovations to the restrooms. The sunroom faces some challenges with cooling due to its design and location; however, no other operational issues have been reported. The current HVAC system is up to date and the electrical service equipment is aging but currently functional.

Due to the historic nature of this building, several systems are beyond their estimated life expectancy but remain in good or fair condition. The slate roof, windows, masonry, and flooring replacement and repairs are priority projects for the near term. The aging systems should be evaluated regularly and provided with maintenance repairs when needed.

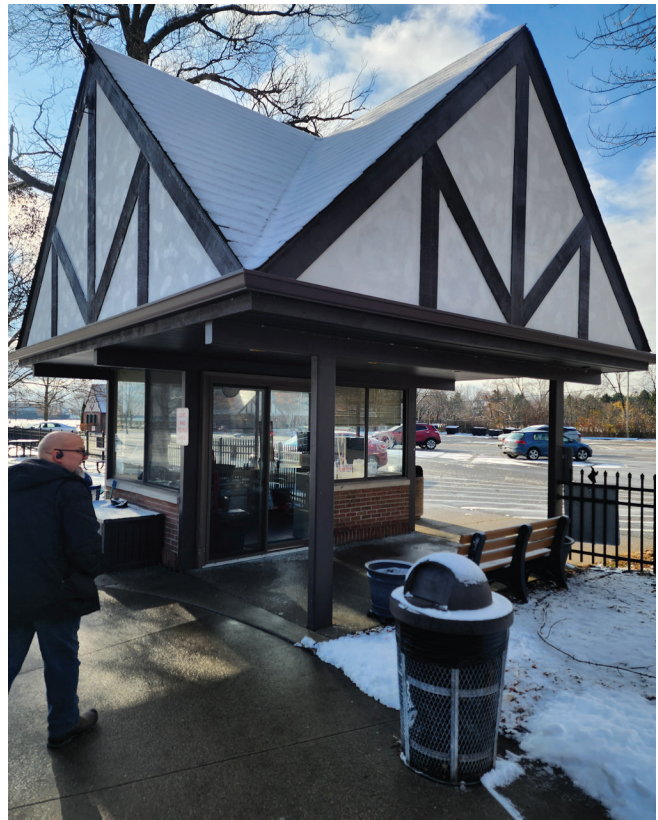
### THE RESTROOMS BUILDING AND CONCESSION STAND

The restroom building and concession stand is a seasonal building that was constructed in the late 1970s to early 1980s and retains mostly original systems. It includes men's and women's restrooms, a concession area (not accessible during the site visit), and a central pump room serving the adjacent fountain. Fountain equipment was replaced within the past year.

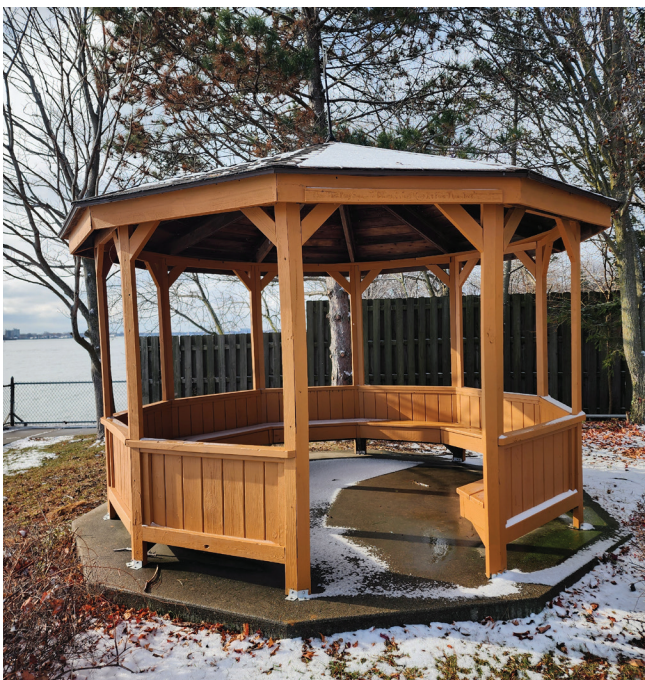
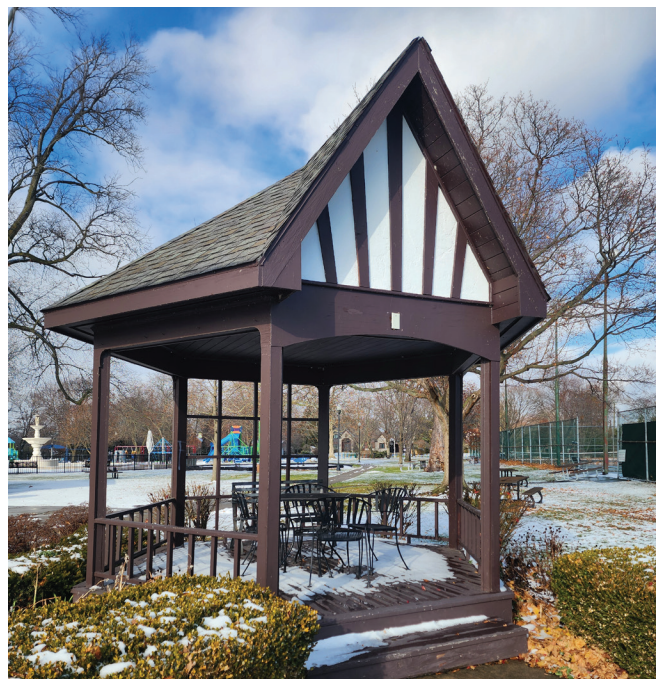
Two gazebos are located on the property and constructed in mid 90s. One of the gazebos was sanded and repainted last year and is in acceptable shape. Some concrete work is still required.

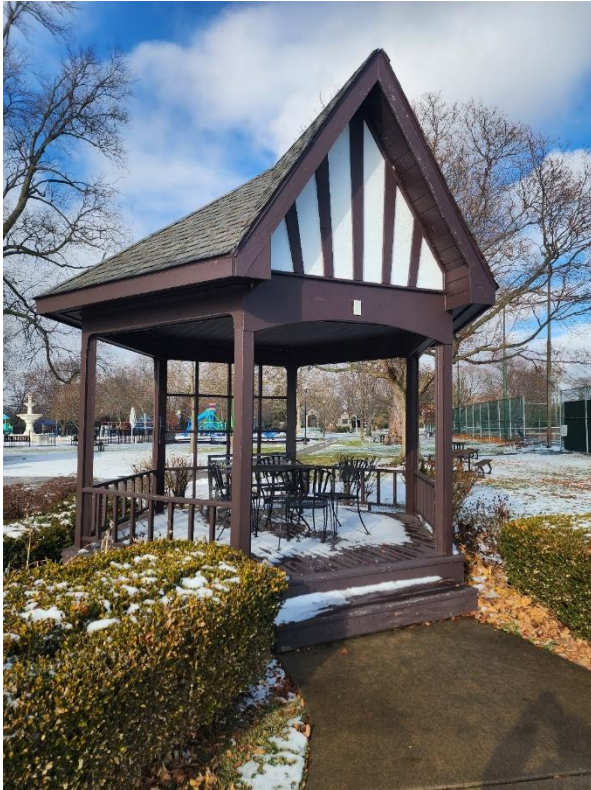
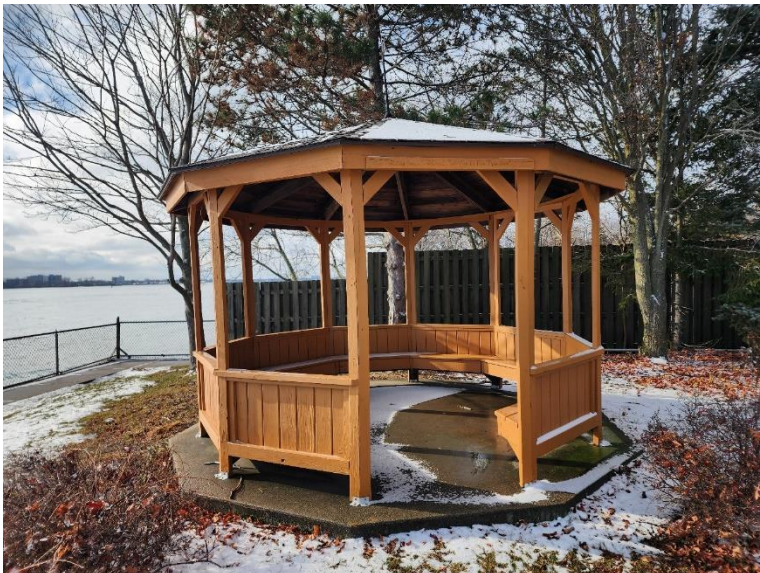
Two gazebos are located on the property and constructed in mid 1990s. One of the gazebos was sanded and repainted last year and is in acceptable shape. Some concrete work is still required.

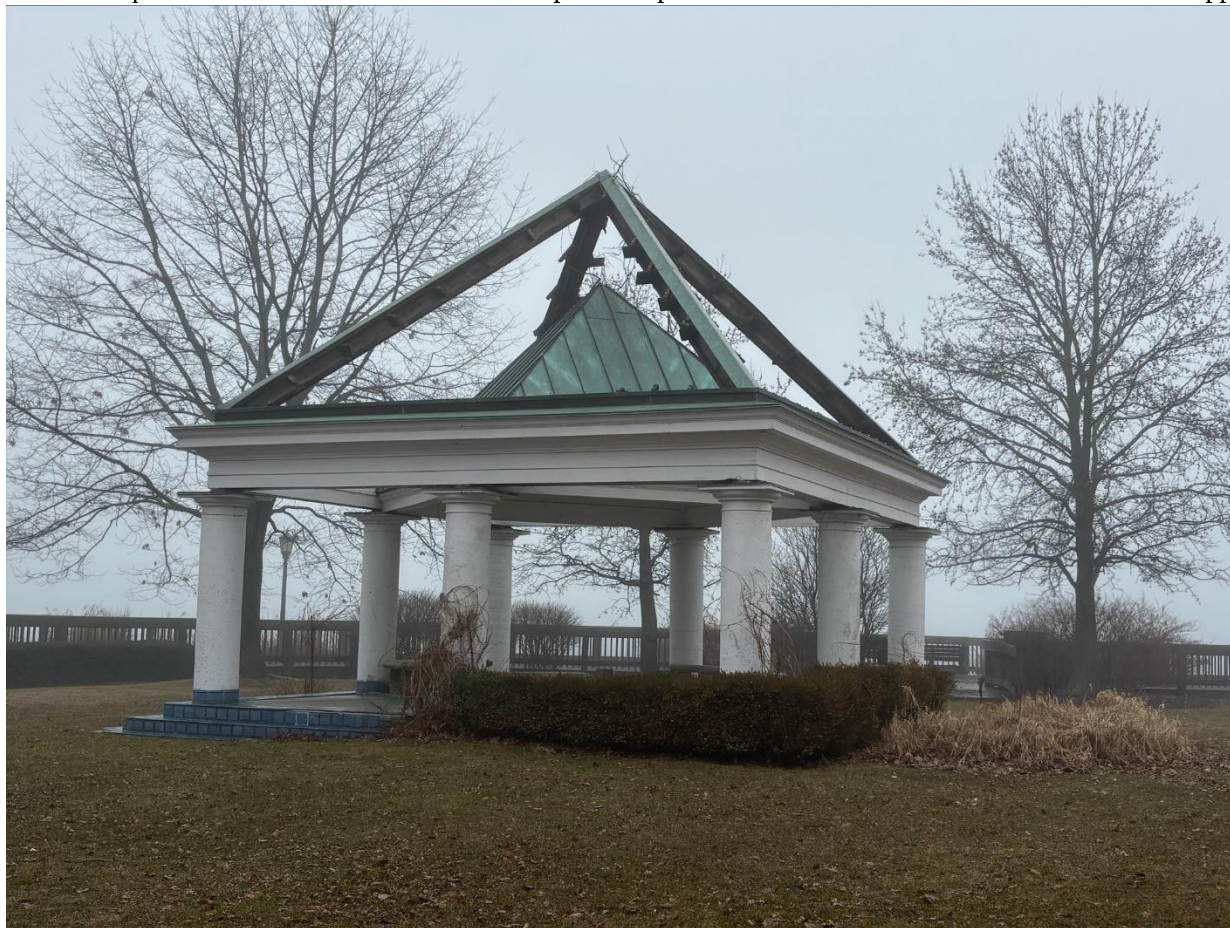
The Willeke Gazebo is the only gazebo located in Patterson Park and is in need of repair. Quotes to reconstruct it range between \$10,500 and \$56,000 depending on the level of reconstruction.

The three quotes received from contractors to repair or replace the Willeke Gazebo can be found in this Appendix.

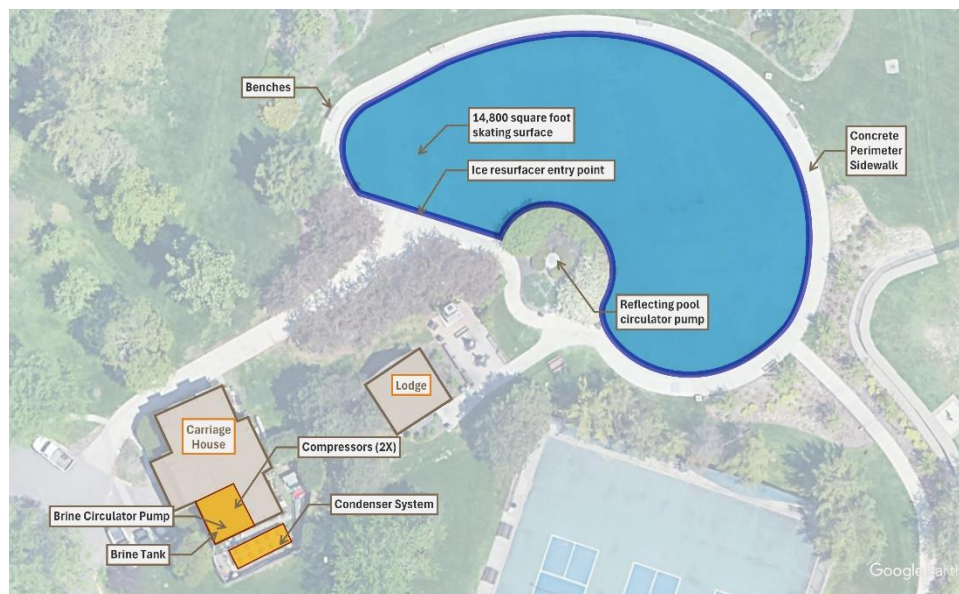
Figure 1 - Patterson Park Rink

The Patterson Park outdoor ice rink was constructed in 1997. The rink itself is a 14,800 square foot, concrete surface which is poured overtop of refrigerant piping. The skating surface is set below grade by approximately 12” and is surrounded by a concrete containment curb which serves to control the water surface. During the winter months, this surface is carefully monitored to ensure that ice does not exceed the height of drains to mitigate risks of heaving. During the summer months, this depressed area is filled with additional water and converted to a reflecting pond. The rink is surrounded by a concrete sidewalk with benches and lighting.

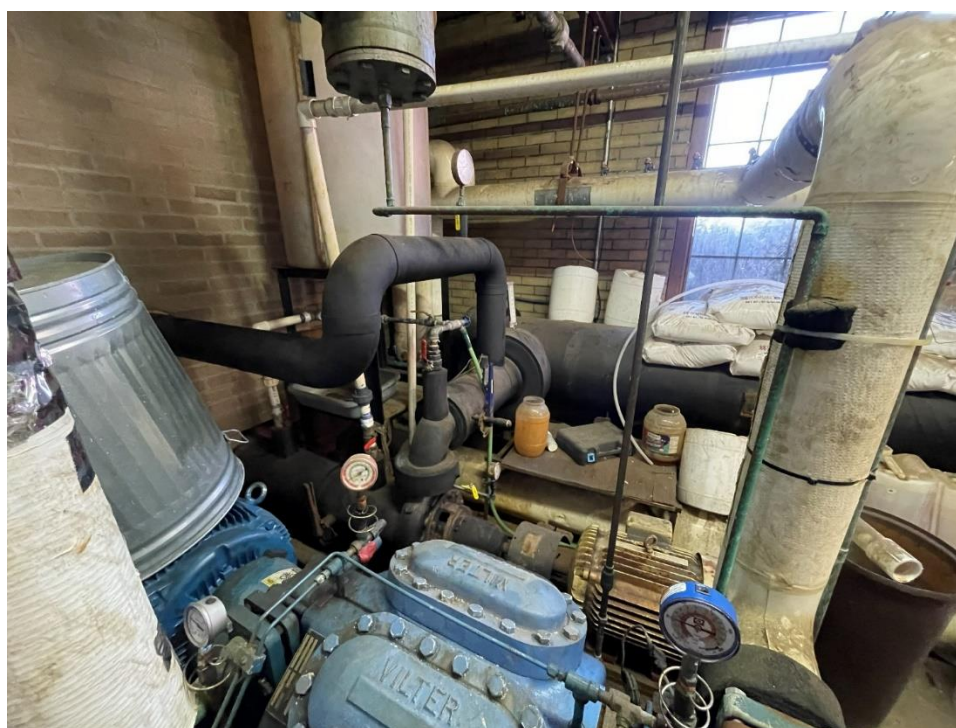
Figure 2 - Brine Circulation System within Carriage House

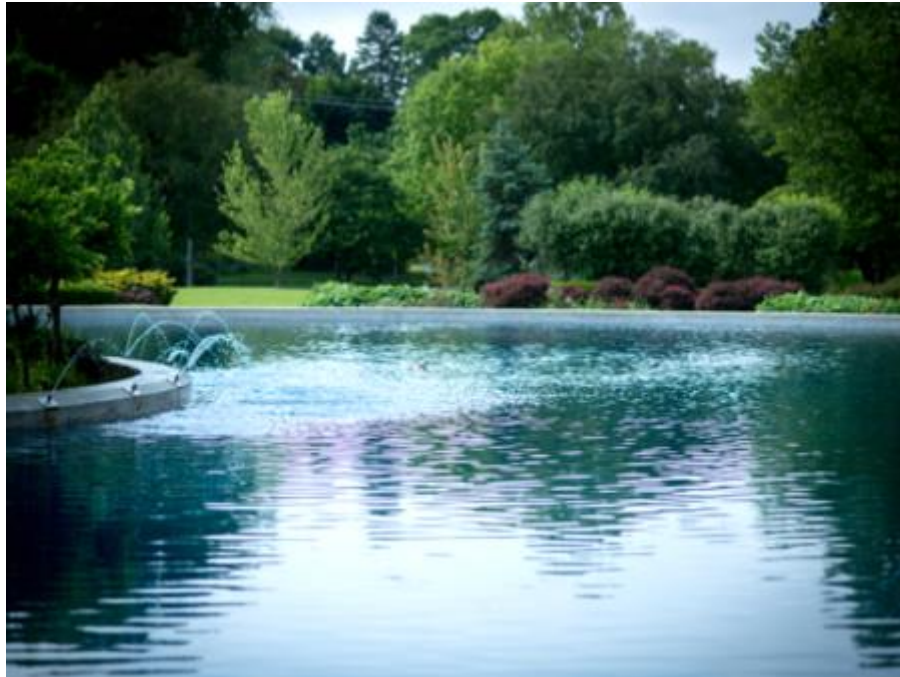
During the spring and summer season, the rink water has been removed, the surface is cleaned of debris. The area is then filled with water from the municipal water supply source. The pool water is kept clear through use of spray heads and a pumped system. Dye is added to the water as well to provide blue color. Additional water is added to the system as needed from the municipal water supply. The water supply for this pond as well as the rest of Patterson Park is currently unmetered.

*Figure 4 - Reflecting Pond (Image from the City of Grosse Pointe Park)*

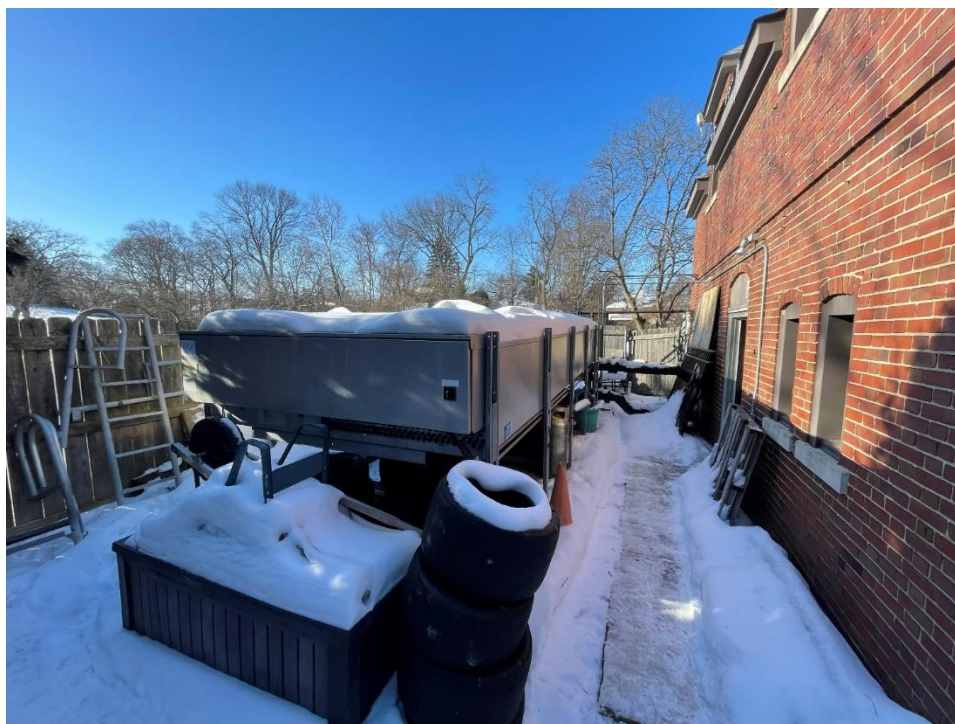
Figure 6 – External Condenser Unit

As part of this effort, the City would replace the existing refrigeration system with a fully new refrigeration utilizing ammonia gas in lieu of freon (note that the existing condenser can likely remain). As a result of the gas, the unit would need to be located outdoors and would likely be placed on the south side of the carriage house. Based on the anticipated noise from the unit, a building of structure capable of dampening and shrouding sound would be necessary. The estimated cost of a new system (excluding structure) \$800,000. This improvement is anticipated to reduce operational costs by X%.

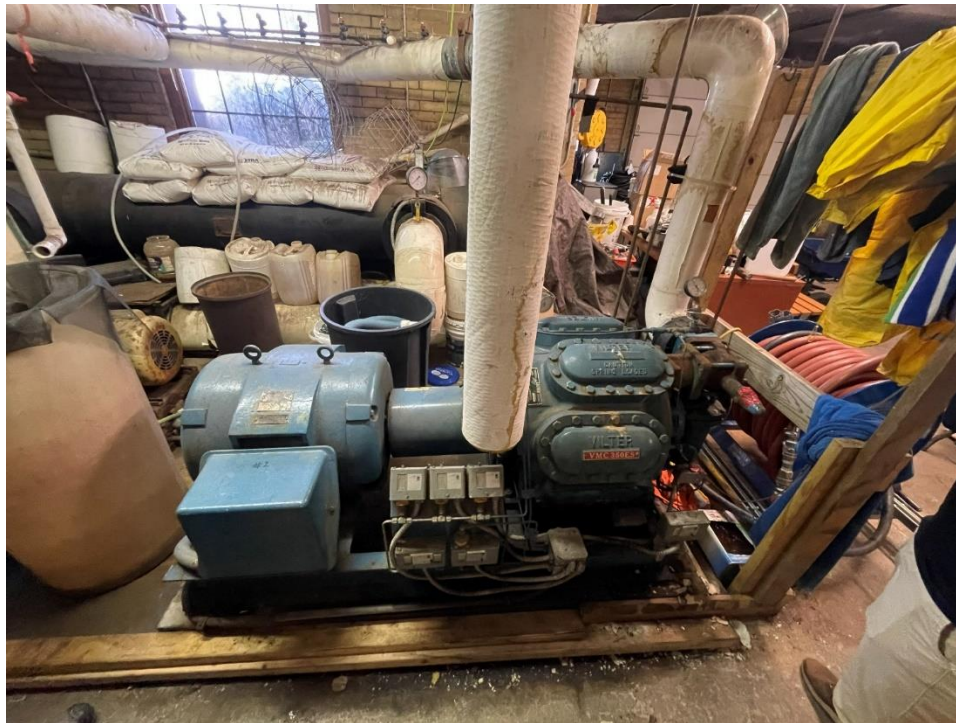
*Figure 7 - Condenser No. 2 to be replaced*

This alternative includes the replacement of the existing condensers with rebuilt VMC 450 ES units. These units would extend the life of the existing system and reduce operating costs through more efficient operation. Viable and rebuilt portions of the existing 350 ES compressors would be salvaged and sold for parts. The cost to perform the rehabilitation is \$3XX,000.

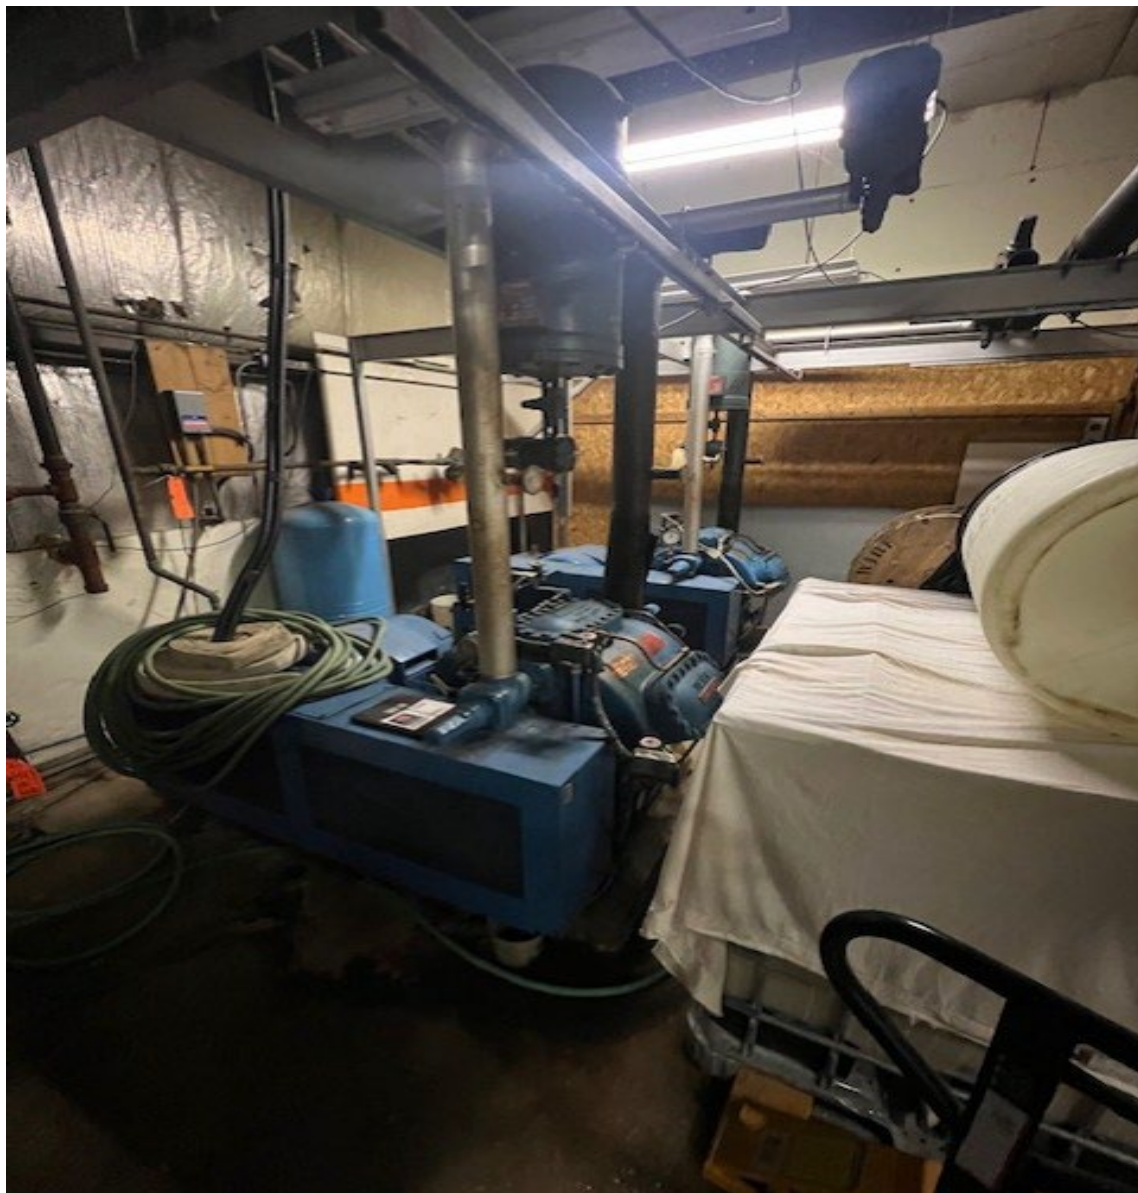
Used Belt Driven Vilter:

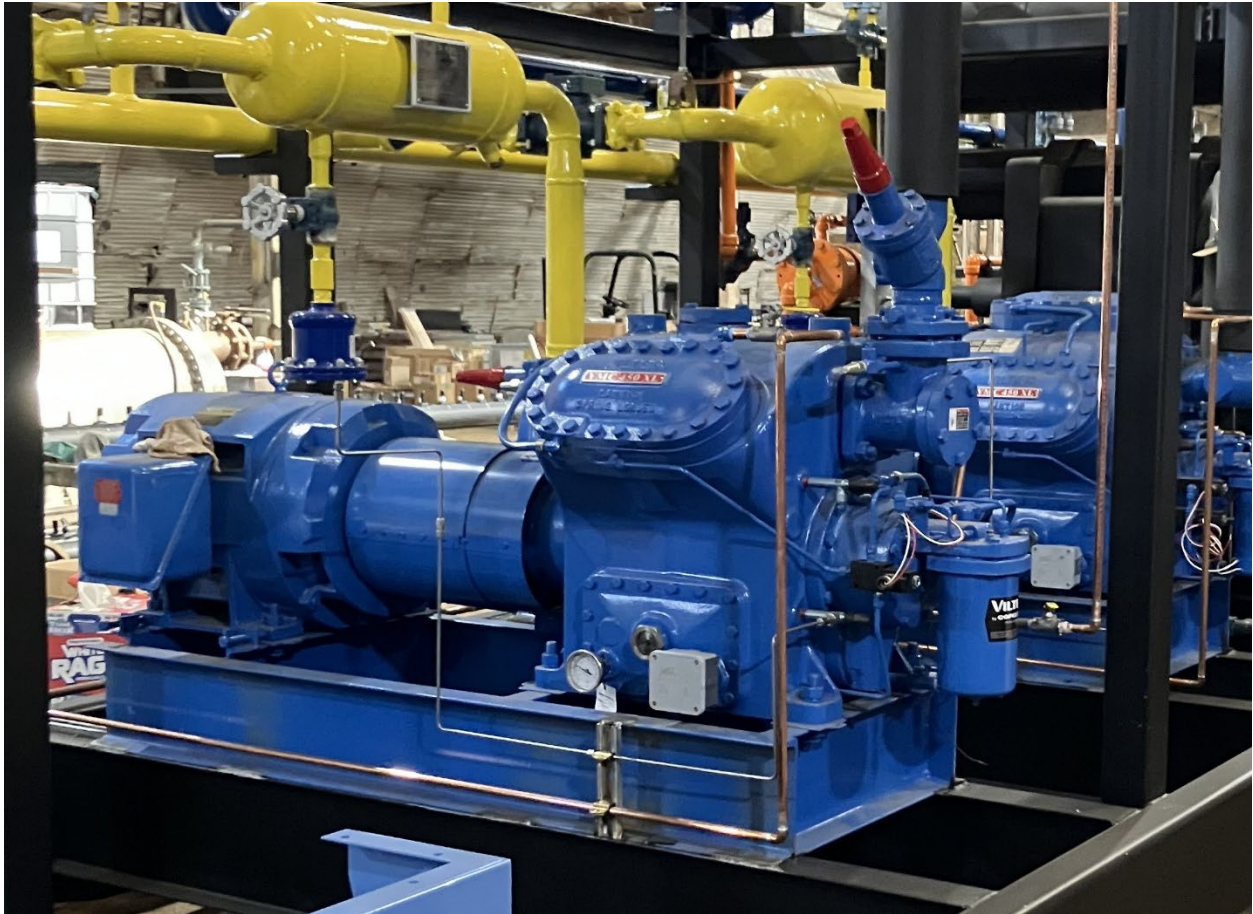
Example New Vilter direct drive compressor:

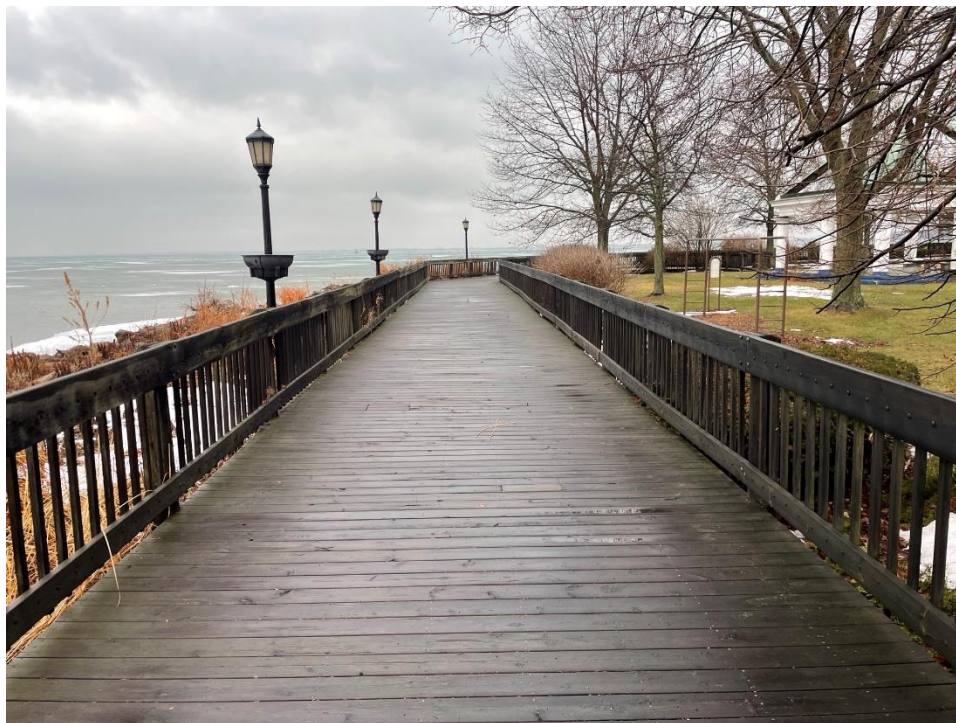
*Figure 1 - Typical view of boardwalk structure - looking southeast*

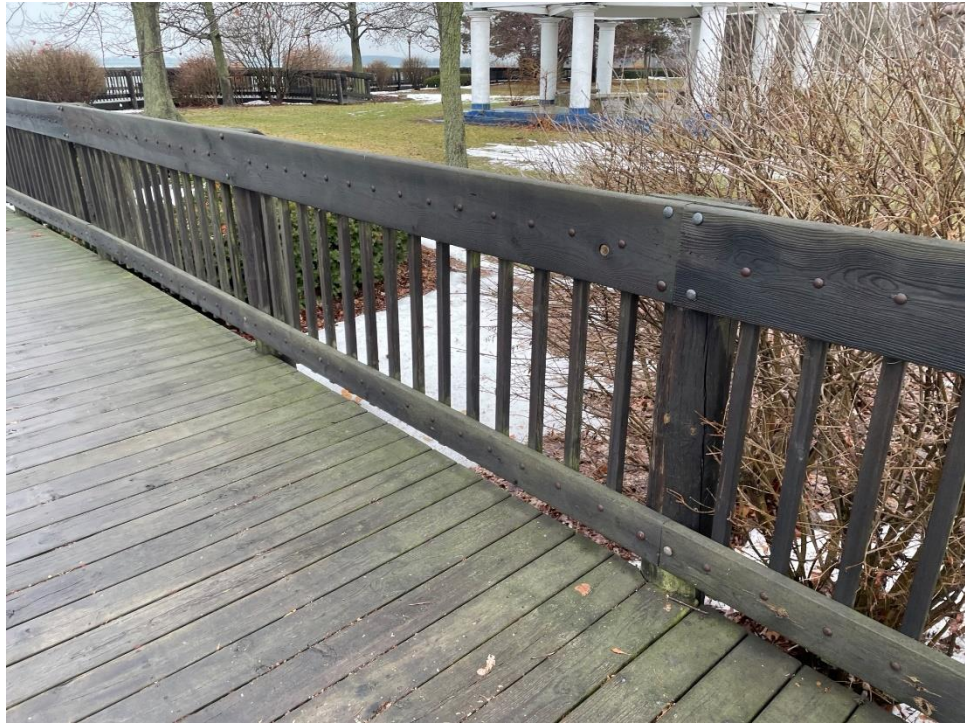
- Continuous along entire boardwalk length
- Railings present at stairway and ramp transitions
- 42-inch height appears appropriate for fall protection
- Baluster spacing (~5-inch openings) does not appear compliant with ADA standards
- No major deformation or failure observed

*Figure 2 - Typical Railing*

- Inspect annually for loosened balusters
- Spot replacement of cracked members

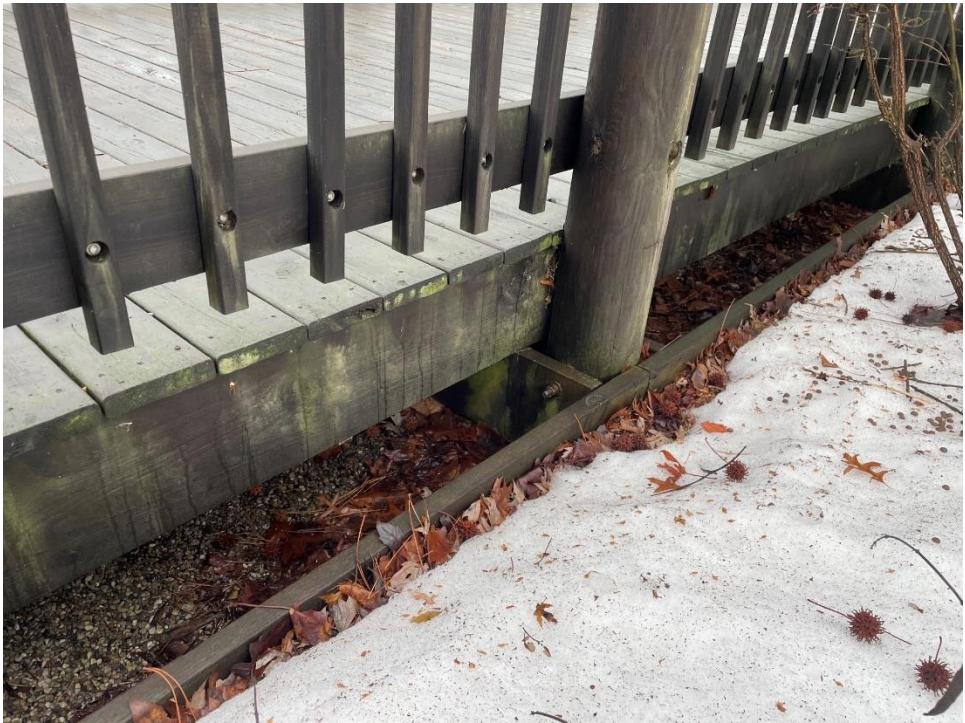
- 12-inch round timber posts appear intact where visible
- Joists and stringers connected via carriage bolts
- Structural members appear near existing grade
- Moisture exposure from soil and lake environment presents risk of:
  - Ground rot
  - Post base deterioration
  - Fastener corrosion

Given the structure's age (40 years), hidden deterioration at post bases and below-grade embedment is a primary long-term concern.

*Figure 3 - Typical boardwalk structure*

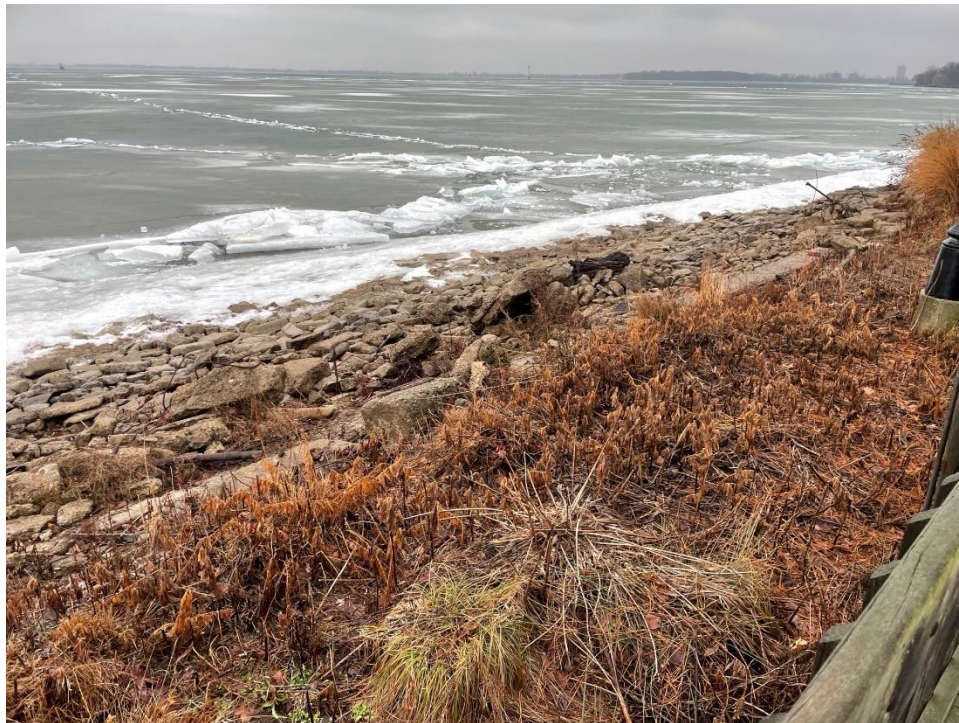
- Shrubs and ornamental grasses between boardwalk and shoreline protection
- Shoreline protection consists of recycled concrete, masonry fragments, riprap stone
- Visible scrap metal, exposed rebar, and debris
- Jagged and unsafe conditions prevent water access

**Risk Level:** Moderate (public safety hazard if accessed)

*Figure 4 - Typical Shoreline Stabilization*

- Remove visible scrap metal and exposed rebar
- Conduct shoreline debris cleanup for hazard mitigation

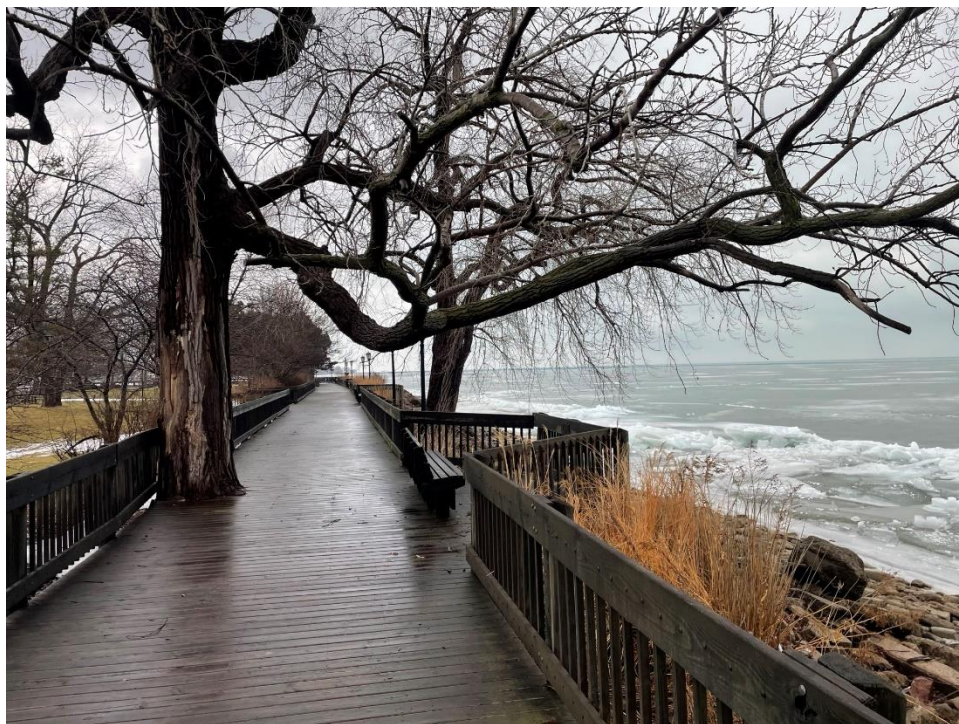
*Figure 5 - Location along boardwalk with slipping hazards and low clearance (6'-8'')*

In the Short Term (0–5 years), targeted maintenance efforts can address the most immediate concerns and improve the accessibility for users. Recommended actions include pressure washing to remove buildup and improve surface conditions, hardware replacement to address corrosion, application of anti-slip treatments to reduce fall risks, and addressing areas where heaving has impacted the boardwalk. Structural probing of post bases is also advised to assess hidden deterioration and determine where reinforcement may be needed. These steps would help mitigate hazards and slow further degradation.
