## AGENDA - Recreation Commission

# PARKS AND RECREATION

# Matthew C. Patterson Park

# Windmill Pointe Park

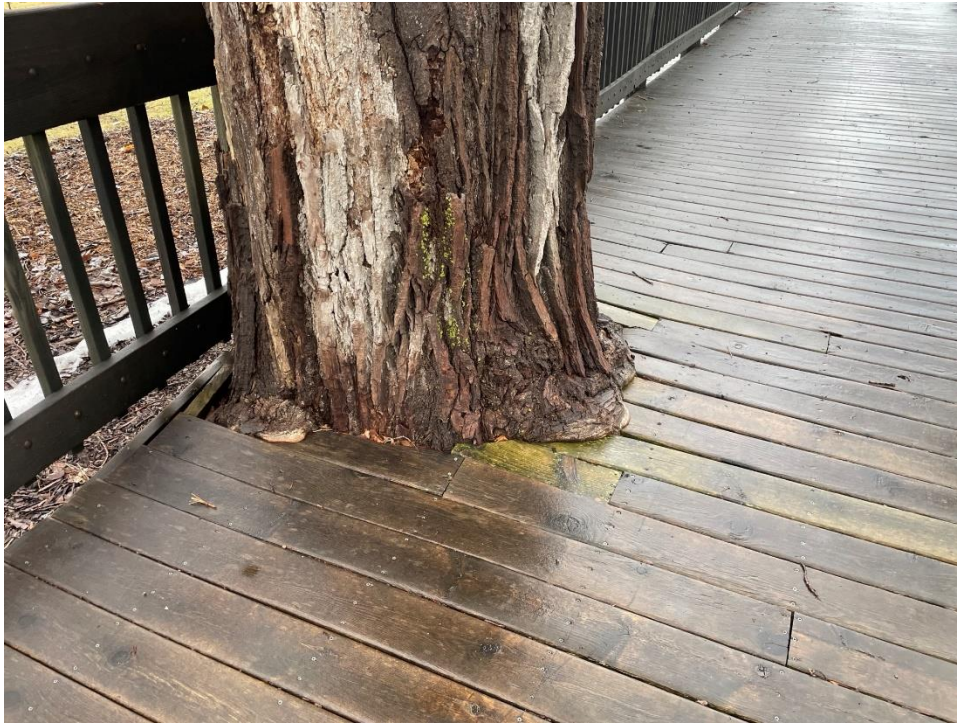
*Figure 6 - Heaved Boardwalk at existing tree*

Over the Mid Term (5–10 years), more substantial structural interventions may be required. This could include selective post replacement and reinforcement of compromised structural components. Establishing a budget for phased rehabilitation during this period would allow the City to address the most critical sections first while spreading costs over multiple fiscal cycles. Continued monitoring and periodic reassessment will be important to ensure that repairs remain effective.

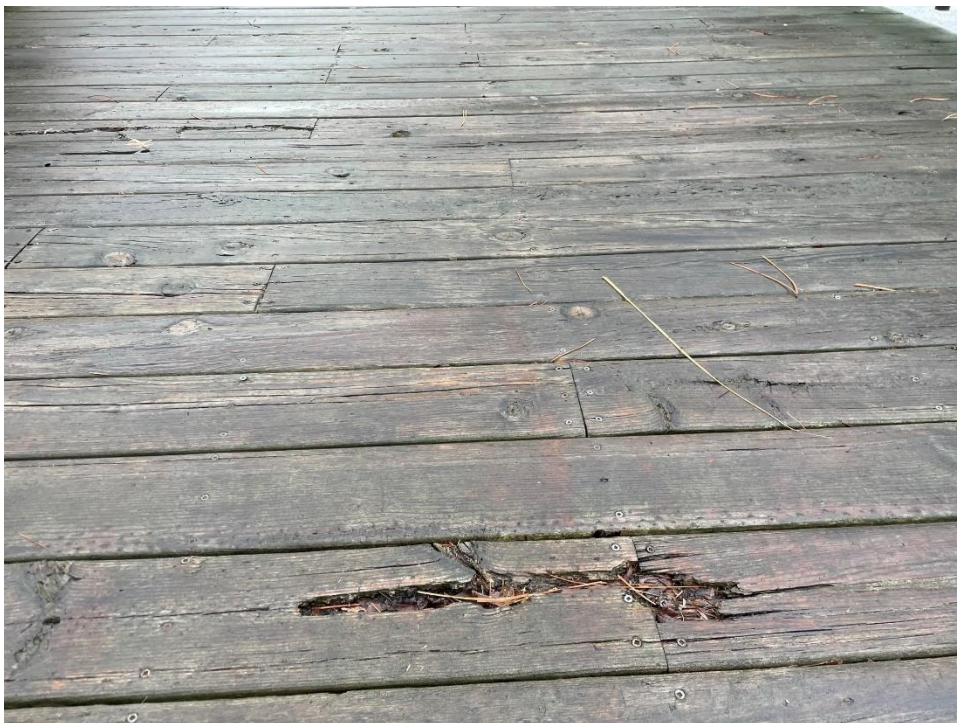
*Figure 7 - Example of typical decking defects*

In the Short Term (0–5 years), targeted maintenance efforts can address the most immediate concerns and improve the accessibility for users. Recommended actions include pressure washing to remove buildup and improve surface conditions, hardware replacement to address corrosion, application of anti-slip treatments to reduce fall risks, and addressing areas where heaving has impacted the boardwalk. Structural probing of post bases is also advised to assess hidden deterioration and determine where reinforcement may be needed. These steps would help mitigate hazards and slow further degradation.

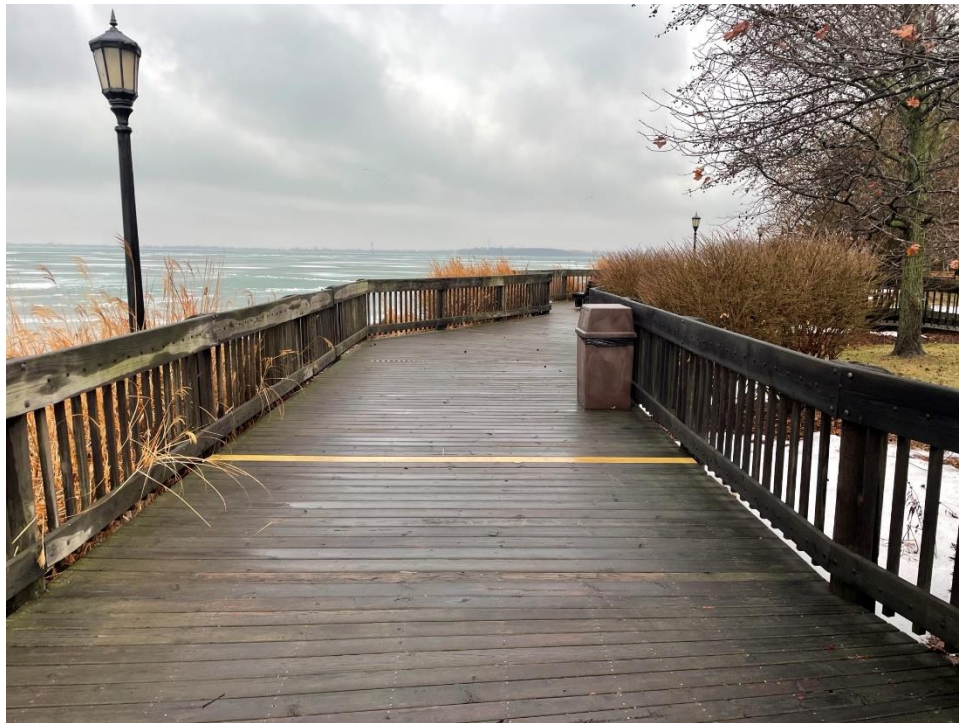
*Figure 8 - Typical shore-side lighting and garbage cans*

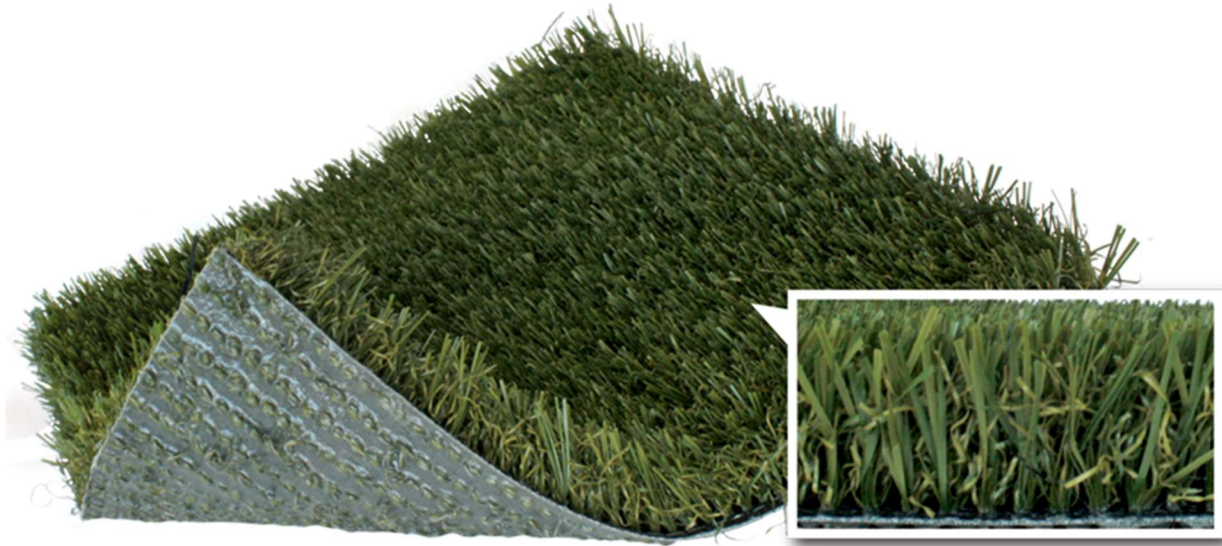
## Landscape Surface –SoftLawn® Bermuda Blend

SoftLawn® Bermuda Blend is a signature product with a thatch layer for added body. The two-color blend of this surface provides an authentic look and feel that resembles a natural lawn. SoftLawn® Bermuda Blend is perfect for high traffic areas. It is ideal for playgrounds and passes ADA standards. This product can also be used for landscapes, pet facilities and golf fringes.

- 
- **Yarn Type:** Polyethylene/ChargeGuard PP
  - **Total Weight:** 87 oz per square yard
  - **Secondary Backing:** SilverBack™ Polyurethane
  - **Pile Height:** 1 1/4"
  - **Roll Width:** 15'
  - **Perforated:** Optional
  - **Color:** Field/Olive with Forest/Olive Thatch
-

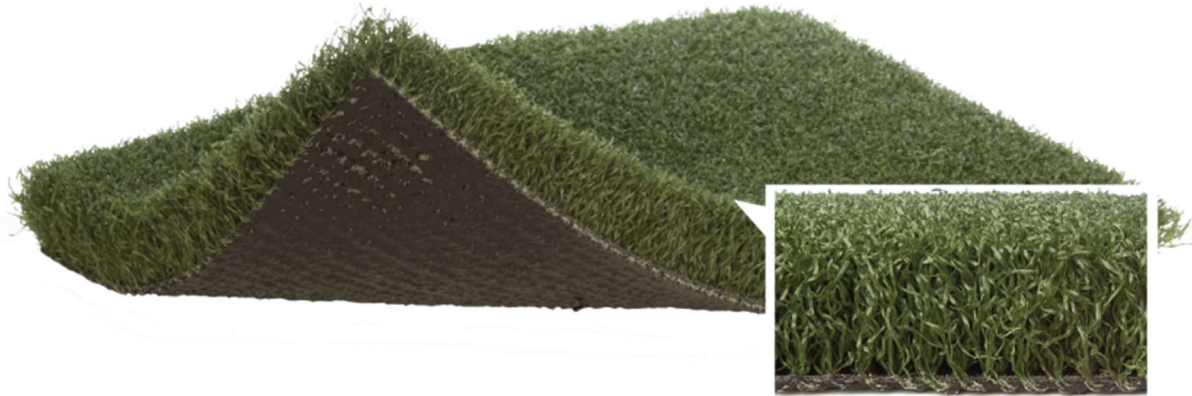
## Chipping Station Surface – EZTee® Poly

The EZTee® Poly features a non-infilled high grade polypropylene yarn system designed for heavy traffic tee lines, hitting mats, and extended use golf ranges. This product holds a real tee and allows players to hit all clubs, from a wedge to a driver and is used by many of the top golf courses around the world. It allows for a true natural swing and provides a divot feel with no club bounce.

- 
- **Yarn Type:** Polyethylene
  - **Total Weight:** 147 oz per square yard
  - **Secondary Backing:** Urethane
  - **Pile Height:** 1 1/8"
  - **Roll Width:** 12'
  - **Perforated:** No
  - **Color:** Pine
-

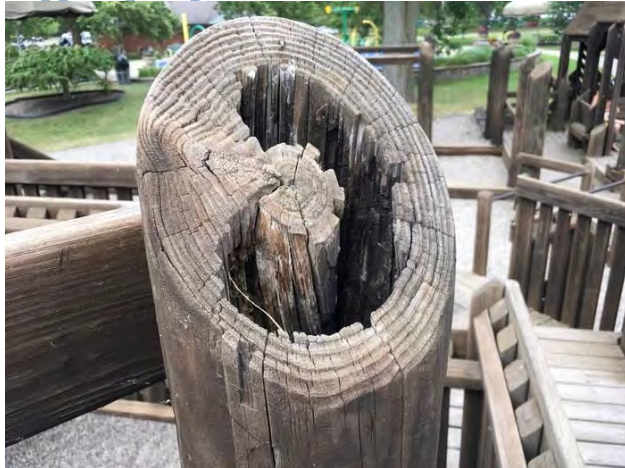
Support post picture #1

Medium: Some visible damage / deterioration / decay observed. Does not appear to be structural at this time.

Repair/replace poles

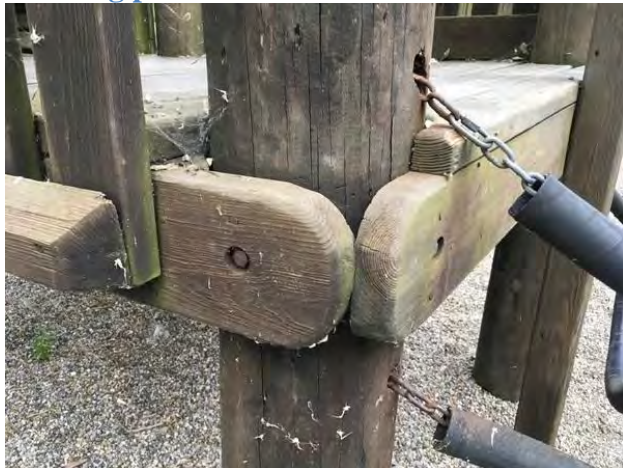
Framing picture #1

Medium: Some visible damage / deterioration / decay observed. Does not appear to be structural at this time.

The framing is in pretty good condition. Minimal checking or splitting at the beam ends.

Repair/replace damage framing with similar materials.

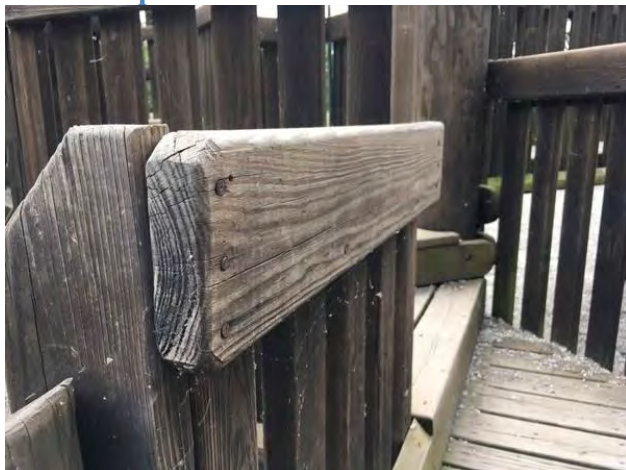
Handrail picture #1

Medium: Some visible damage / deterioration / decay observed. Does not appear to be structural at this time.

Replace handrails with similar materials.

Replacing the handrails with new plastic lumber.

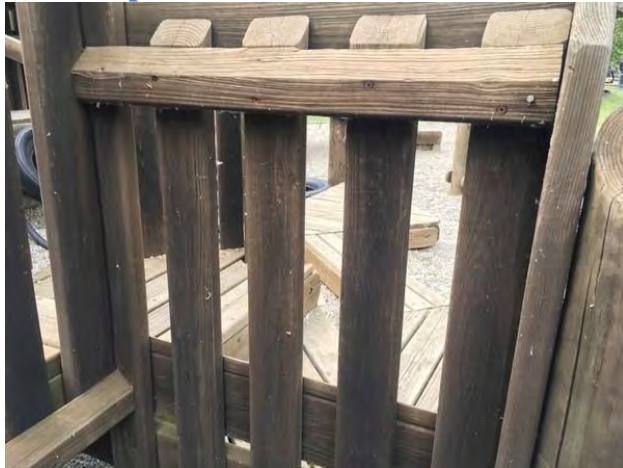
Baluster picture #1

Medium: Some visible damage / deterioration / decay observed. Does not appear to be structural at this time.

Replace balusters with similar materials.

Replace balusters with new 2x2 plastic lumber for improved visibility.

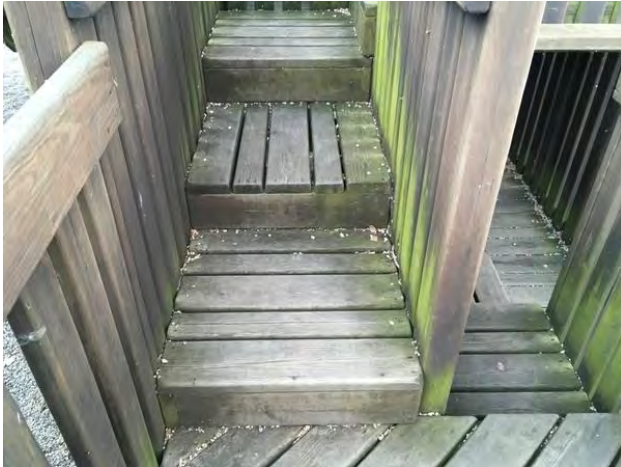
**Maze cube Picture #1**

Medium: Some visible damage / deterioration / decay observed. Does not appear to be structural at this time.

The cubes are in good condition, but the decking is old and splintering.

Replace decking on maze cubes with similar materials.

Replace decking on maze cubes with new plastic lumber.

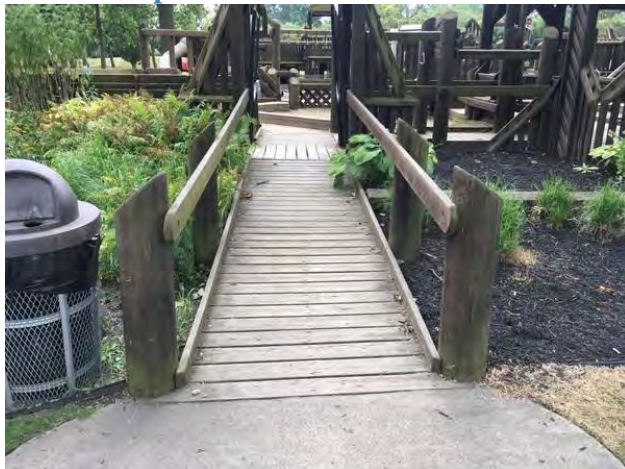
### Accessible picture #1

Medium: Some visible damage / deterioration / decay observed. Does not appear to be structural at this time.

Replace decking with new plastic lumber and add new ADA ramp rails.

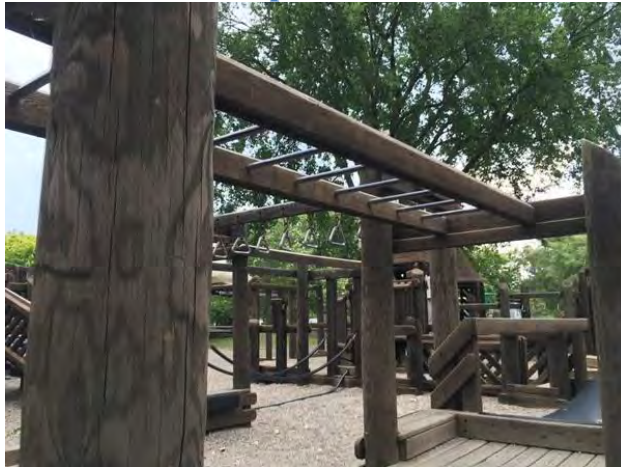
Horizontal Ladder picture #1

Maximum of 15" center to center of rungs?

Replace with new manufactured Overhead Ladder.

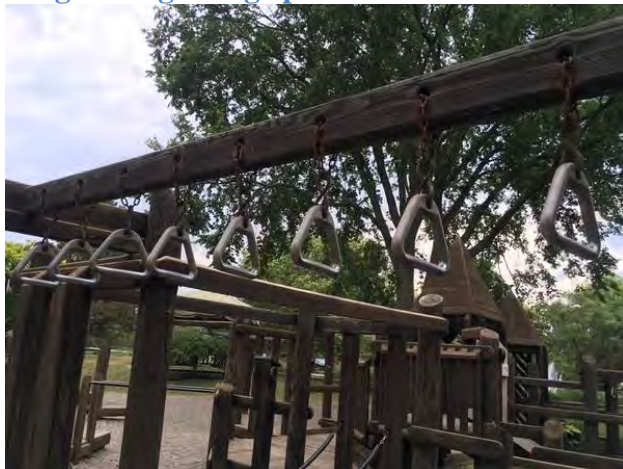
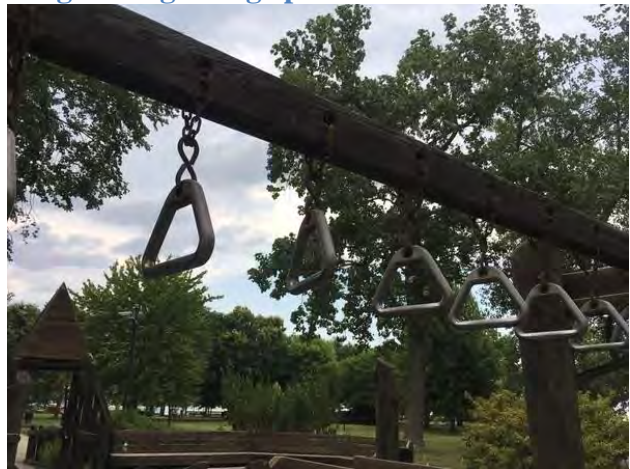
Rings / Ring Bridge picture #1

Medium: Some visible damage / deterioration / decay observed. Does not appear to be structural at this time.

This item is showing signs of wear.

Replace with similar materials.

Replace with new manufactured Ring Bridge.

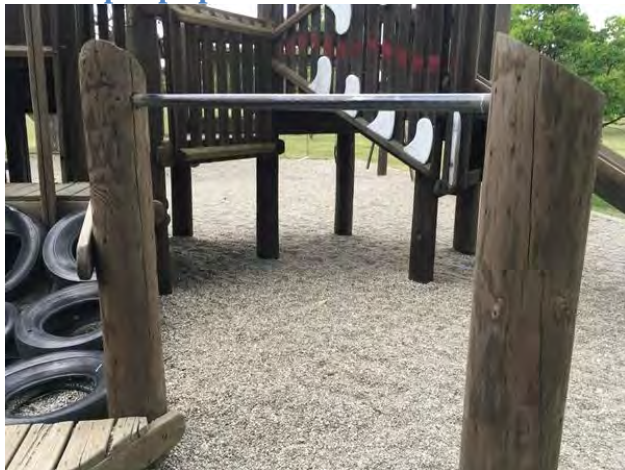
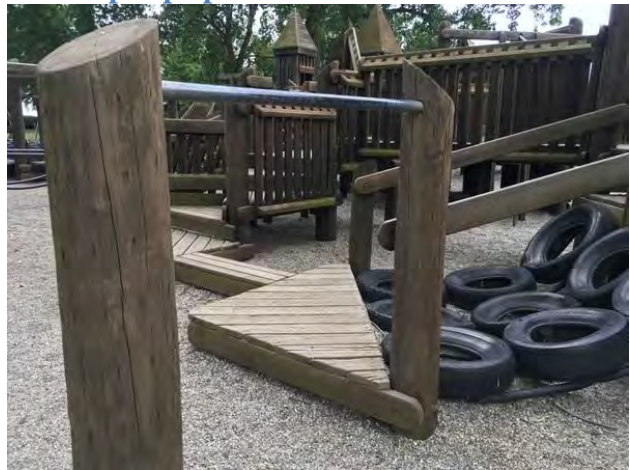
**Chin Up Pipe picture #1**

Medium: Some visible damage / deterioration / decay observed. Does not appear to be structural at this time.

Remove this item.

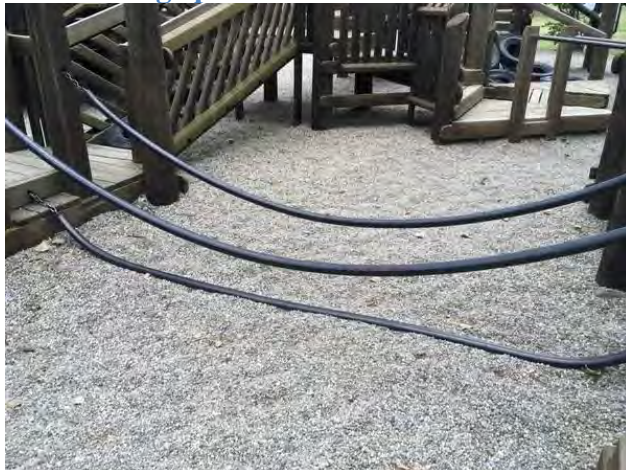
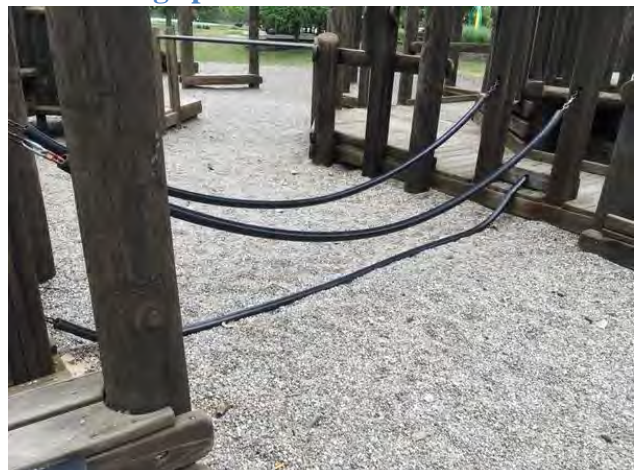
Chain bridge picture #1

Medium: Some visible damage / deterioration / decay observed. Does not appear to be structural at this time.

Replace with new chain and hose.

Replace with new cable version.

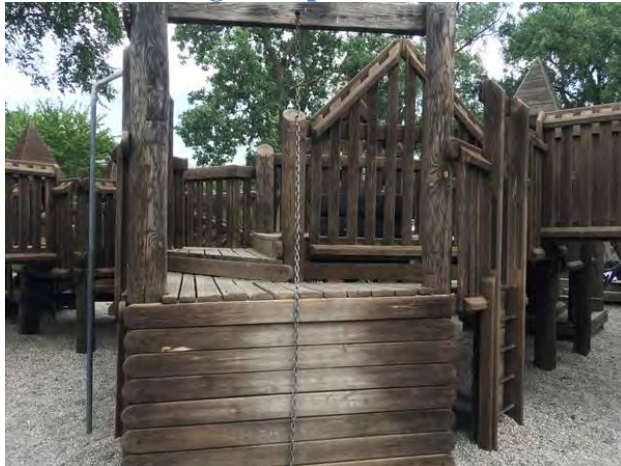
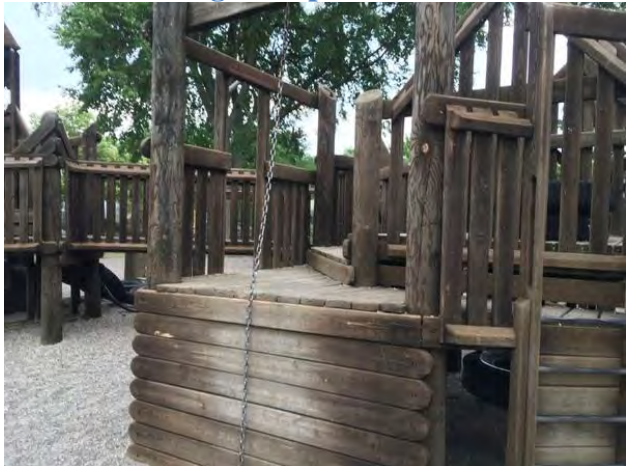
Chain Climbing Wall picture #1

Medium: Some visible damage / deterioration / decay observed. Does not appear to be structural at this time.

Replace with new chain and hose. Narrow down opening of deck with similar materials.

Replace with new cable version. Narrow down opening of deck with new plastic lumber.

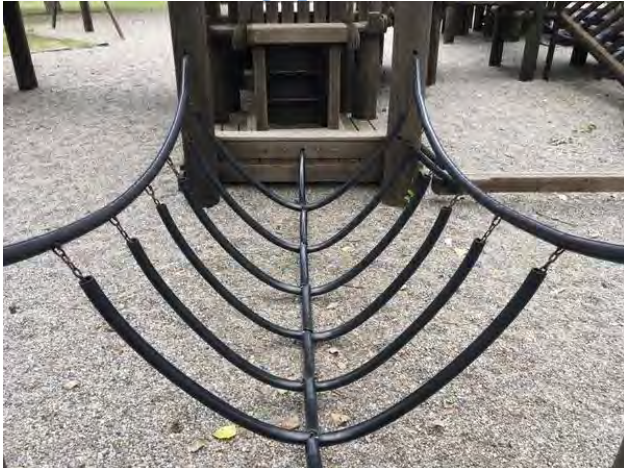
### Chain Cradle Bridge picture #1

Medium: Some visible damage / deterioration / decay observed. Does not appear to be structural at this time.

This item needs repair or replacement

Replace with new chain and hose and updated design.

Replace with new cable version.

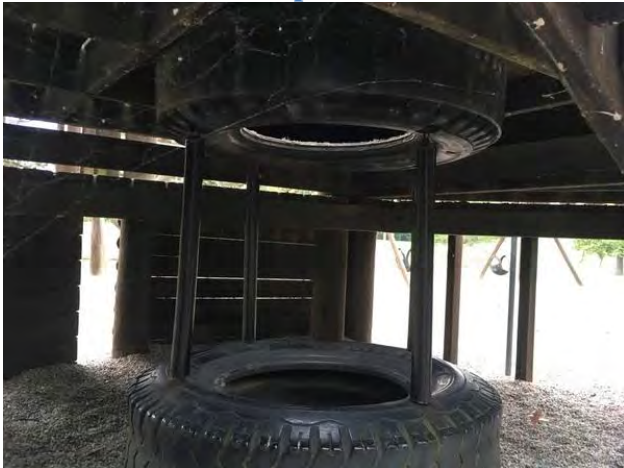
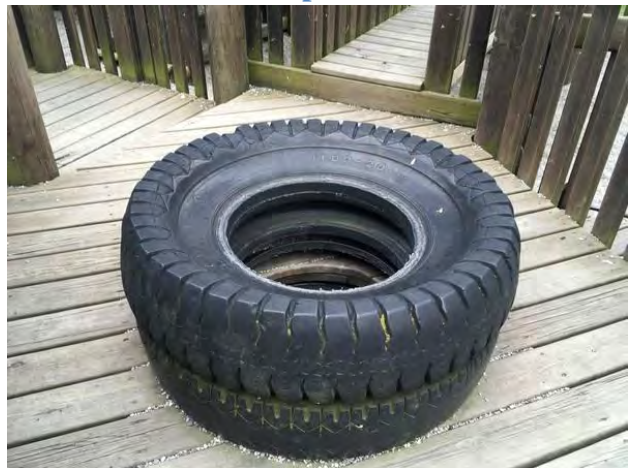
Vertical Tire Tunnel picture #1

Medium: Some visible damage / deterioration / decay observed. Does not appear to be structural at this time.

There was talk about maintenance issues with this item. It isn't in bad condition and is still functioning.

Leave as is.

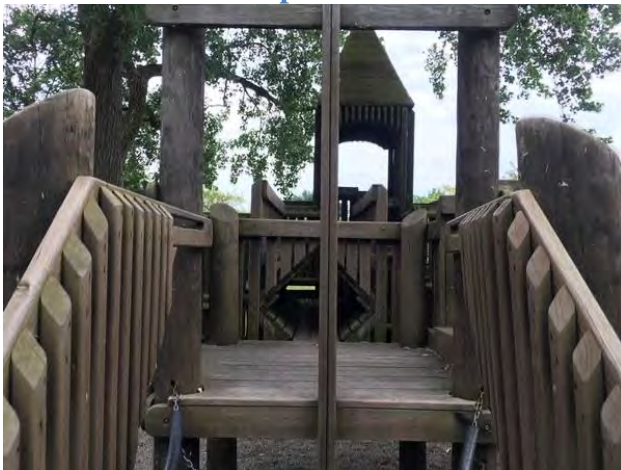
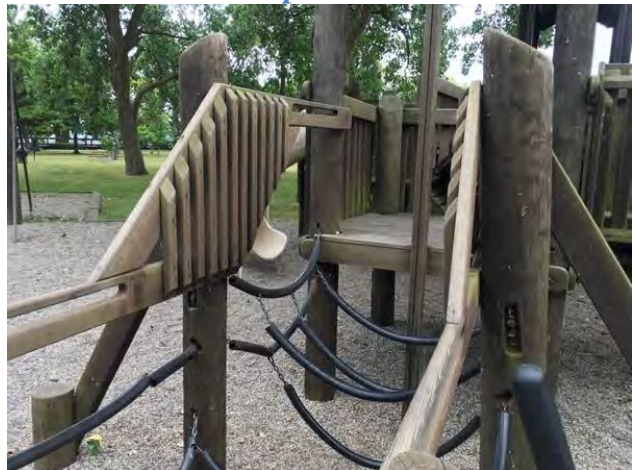
Chain Soft Climber picture #1

Medium: Some visible damage / deterioration / decay observed. Does not appear to be structural at this time.

Replace with new chain and hose. Reduce the openings at the upper deck with similar materials.

Remove & replace with cable version. Reduce the openings at the upper deck with new plastic lumber.

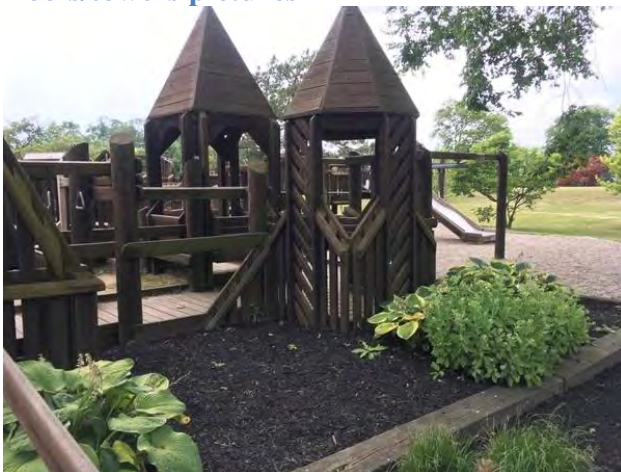
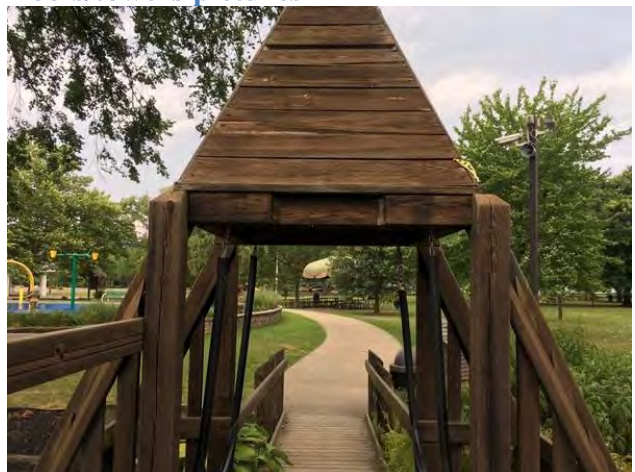
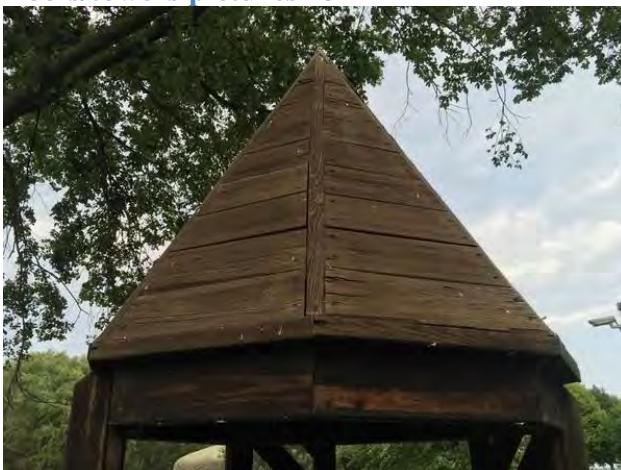
Roofs/towers pictures #1

Medium: Some visible damage / deterioration / decay observed. Does not appear to be structural at this time.

Some boards have become loose, and many are splintering

Replace/replace loose or rotted boards with similar materials.

Replace with new plastic lumber.

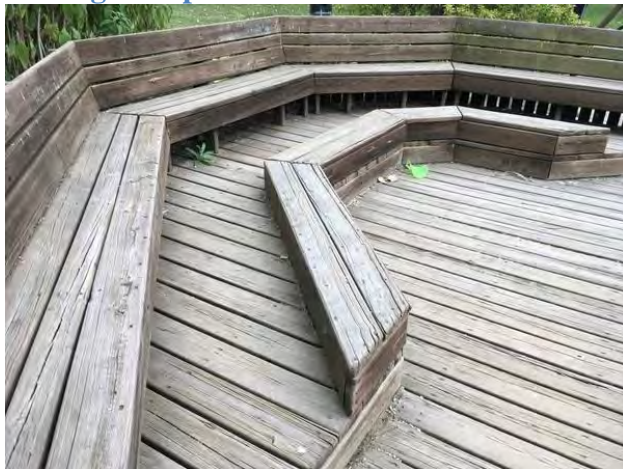
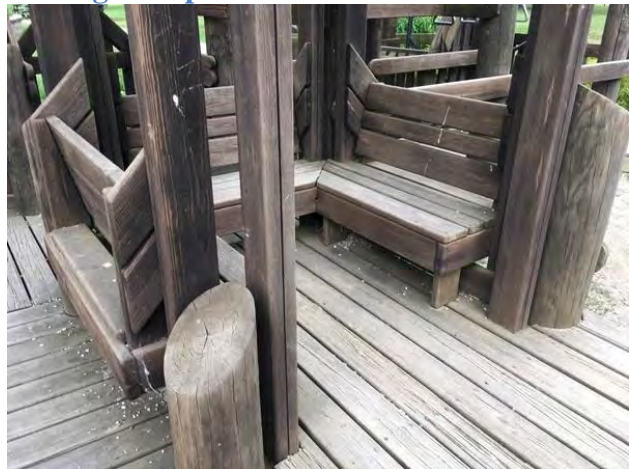
Seating area pictures #1

Medium: Some visible damage / deterioration / decay observed. Does not appear to be structural at this time.

Replace decking with similar materials. Repair/Replace any badly damaged framing with similar materials.

Replace decking with new plastic lumber. Repair/Replace any badly damaged framing with similar materials.

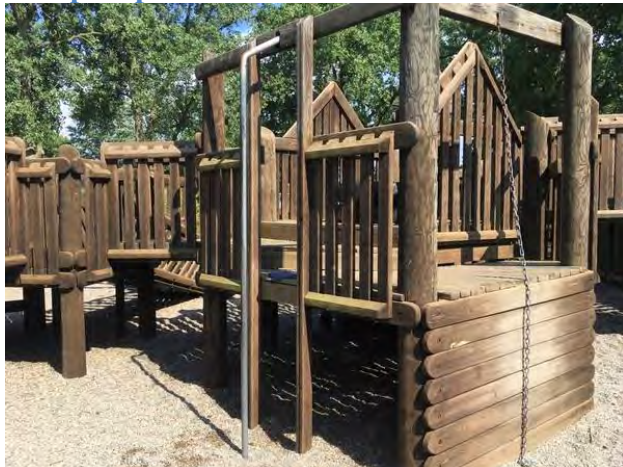
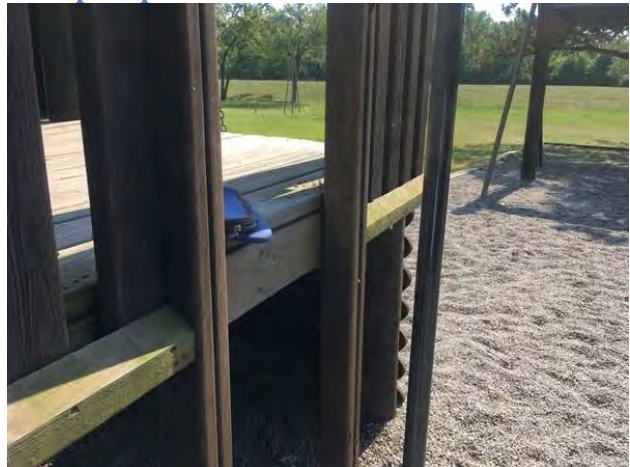
Fire pole picture #1

Medium: Some visible damage / deterioration / decay observed. Does not appear to be structural at this time.

Replace with new fire pole. Narrow down the opening of the deck with similar materials.

Replace with new fire pole. Narrow down the opening of the deck with new plastic lumber.

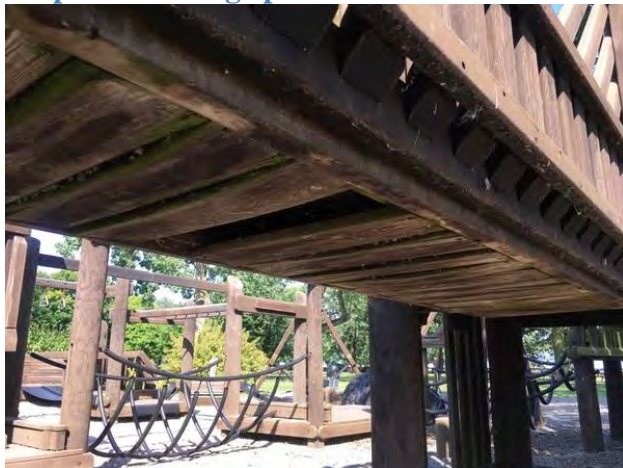
Suspension bridge picture #1

Medium: Some visible damage / deterioration / decay observed. Does not appear to be structural at this time.

Make this item a fixed bridge with similar materials.

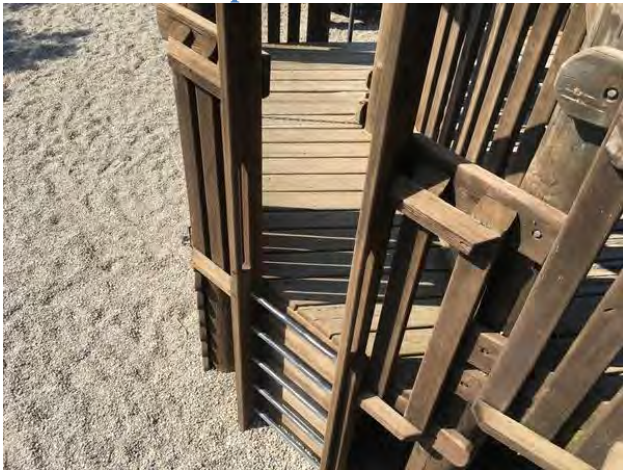
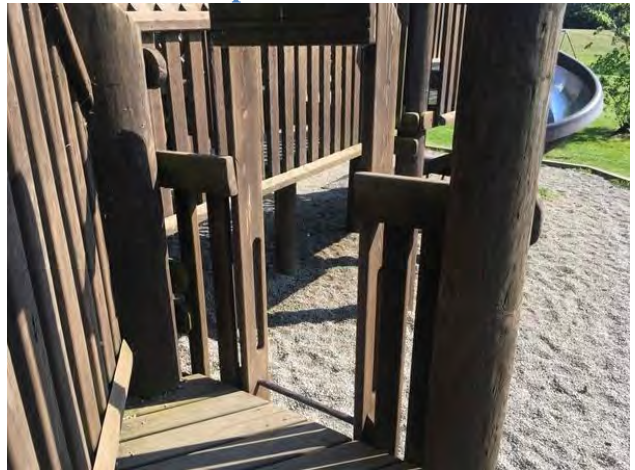
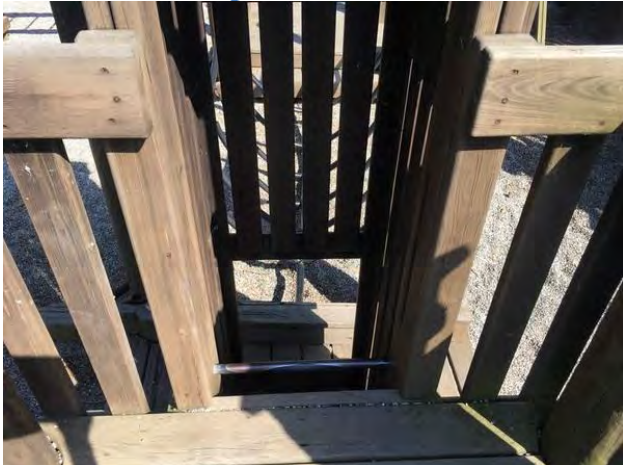
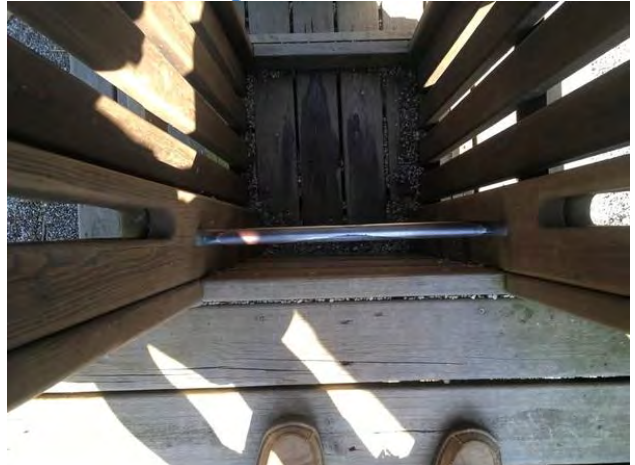
Vertical Ladder picture #1

Medium: Some visible damage / deterioration / decay observed. Does not appear to be structural at this time.

Rebuild Vertical Ladder with new plastic lumber.

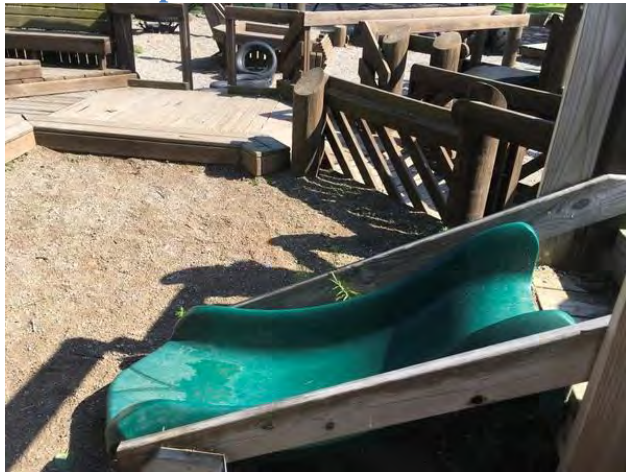
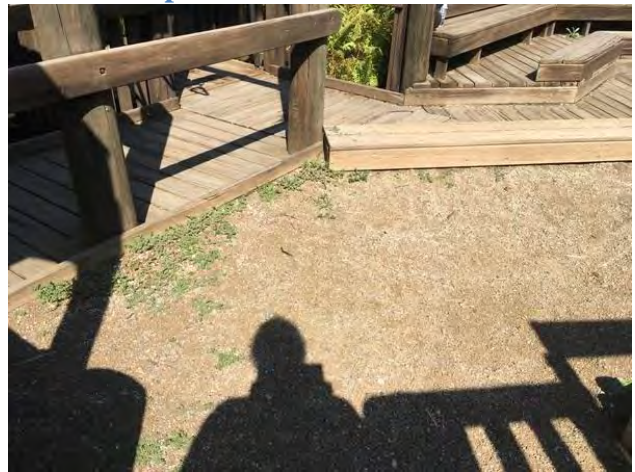
Sandboxes picture #1

Medium: Some visible damage / deterioration / decay observed. Does not appear to be structural at this time.

Add play sand to appropriate level. Build higher walls around the sandbox to help keep sand in. Replace the slide without the board on the side.

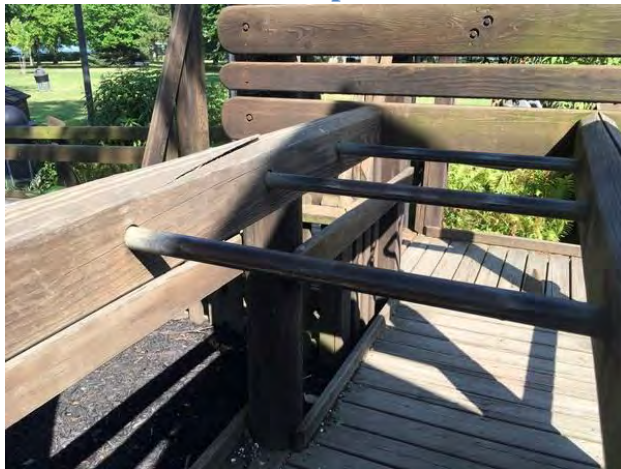
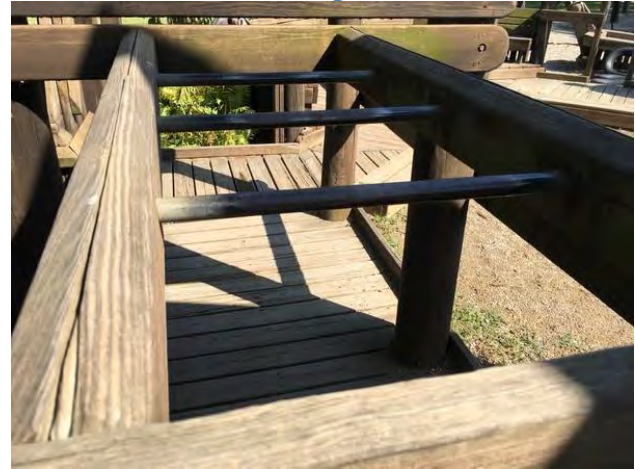
Low Accessible Ladder picture #1

Medium: Some visible damage / deterioration / decay observed. Does not appear to be structural at this time.

Rebuild with similar materials.

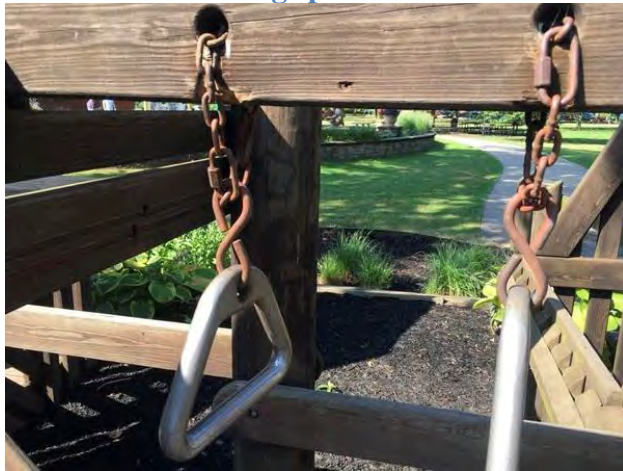
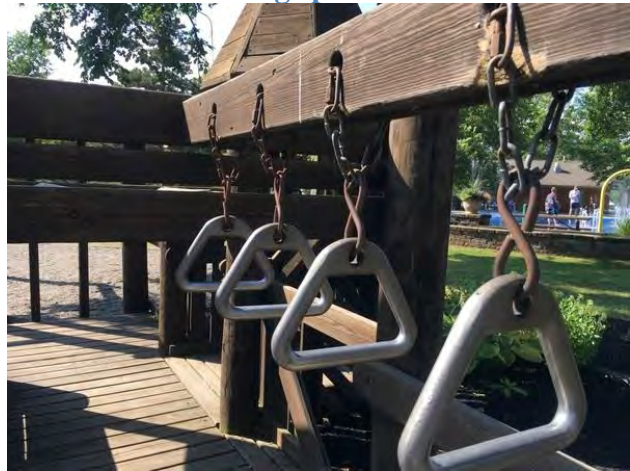
Low Accessible Rings picture #1

Medium: Some visible damage / deterioration / decay observed. Does not appear to be structural at this time.

The beam is showing some wear. The S hooks are closed in properly and the chains are Rusty's

Rebuild with similar materials.

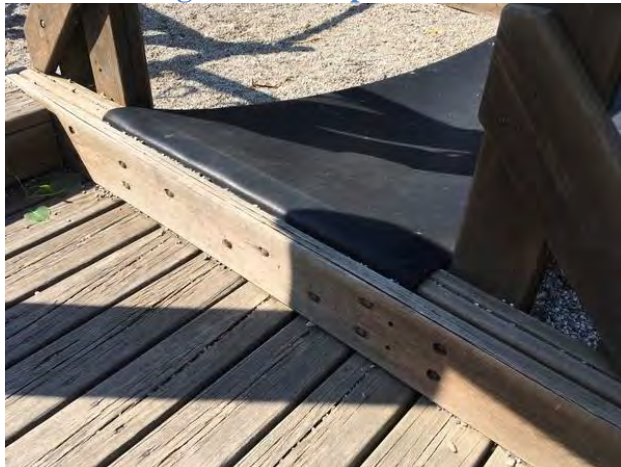
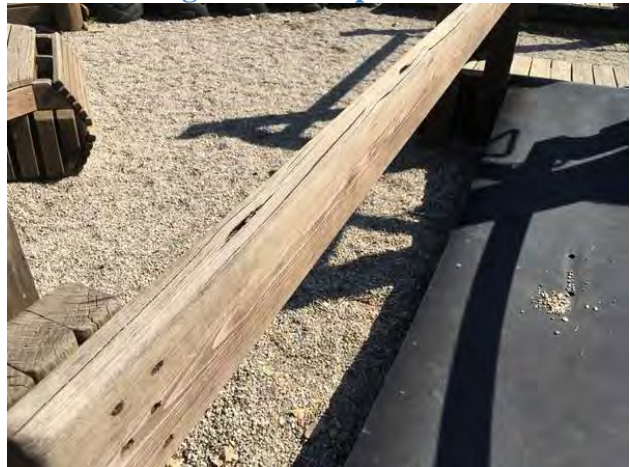
Rubber bridge 5-12 area picture #1

Medium: Some visible damage / deterioration / decay observed. Does not appear to be structural at this time.

Replace the handrails with similar materials. Replace the rubber and the 2x8s on both ends with similar materials.

Rebuild with new plastic lumber with new conveyer belt.

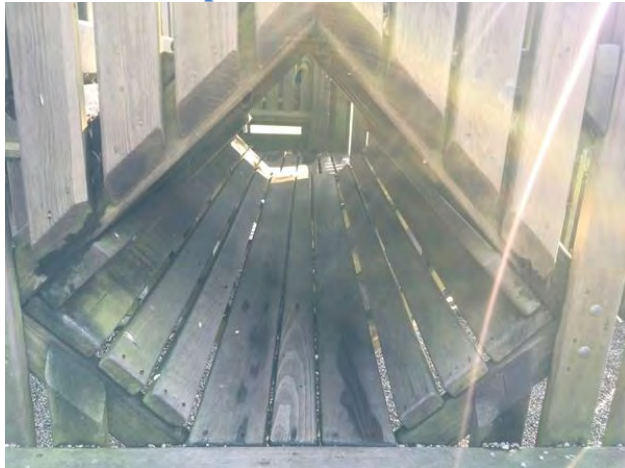
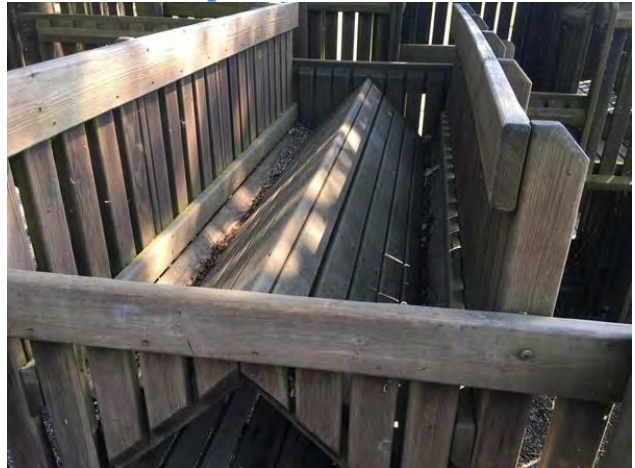
Crawl Tunnel picture #1

Medium: Some visible damage / deterioration / decay observed. Does not appear to be structural at this time.

Leave as is.

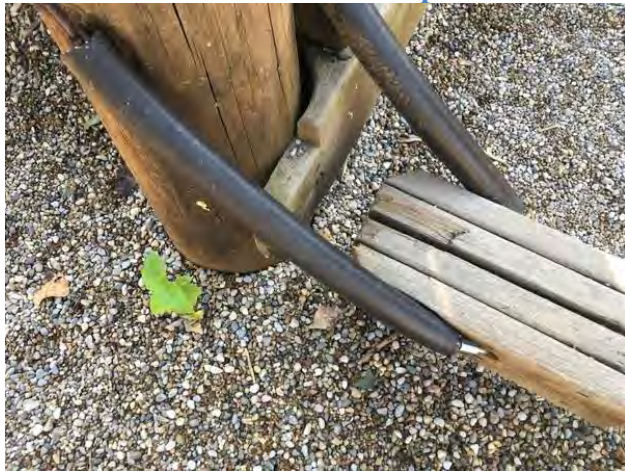
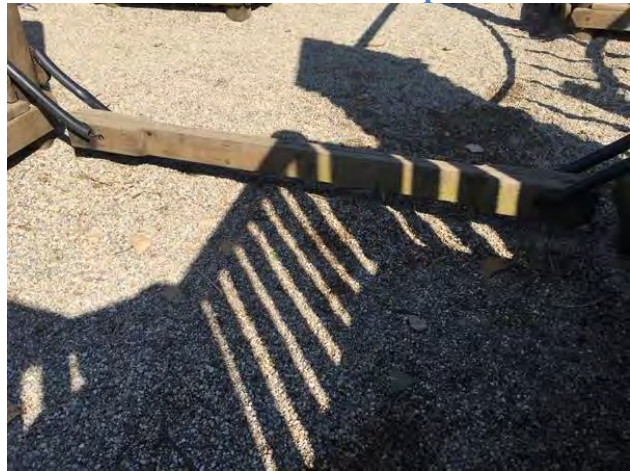
Balance Beam on Chains 5-12 picture #1

Medium: Some visible damage / deterioration / decay observed. Does not appear to be structural at this time.

The beam isn't properly centered and poses a hazard on one end.

Replace with stationary balance beam using similar materials.

Replace with new spring version.

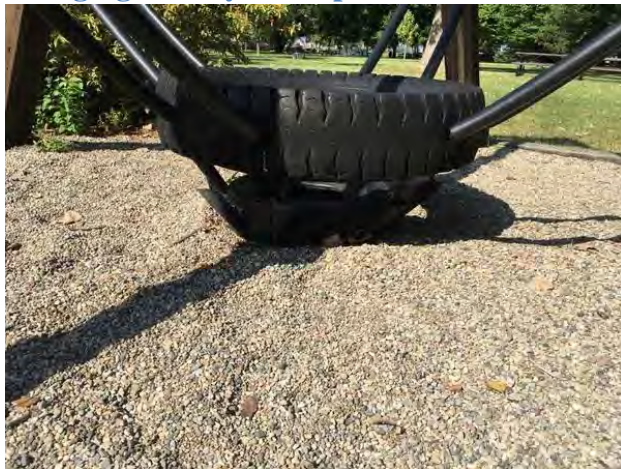
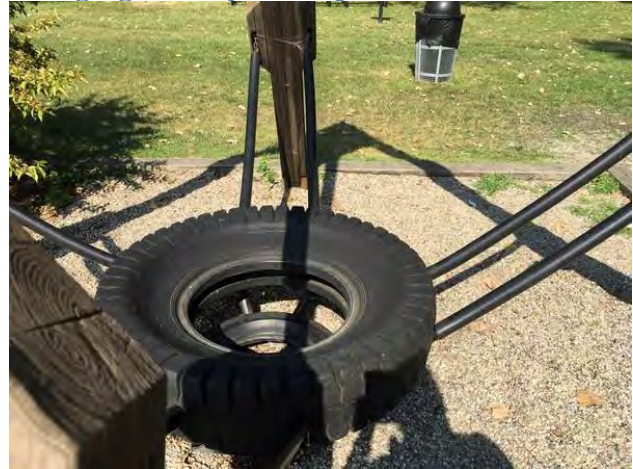
Swinging Tire Pyramid picture #1

#### Swinging Tire Pyramid condition

Medium: Some visible damage / deterioration / decay observed. Does not appear to be structural at this time.

The tires are low and the chain is rusty. There's significant amount of chain exposed

Replace with new manufactured Team Swing.

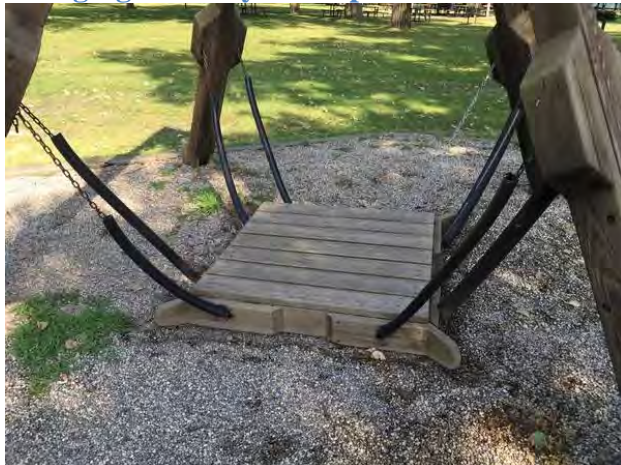
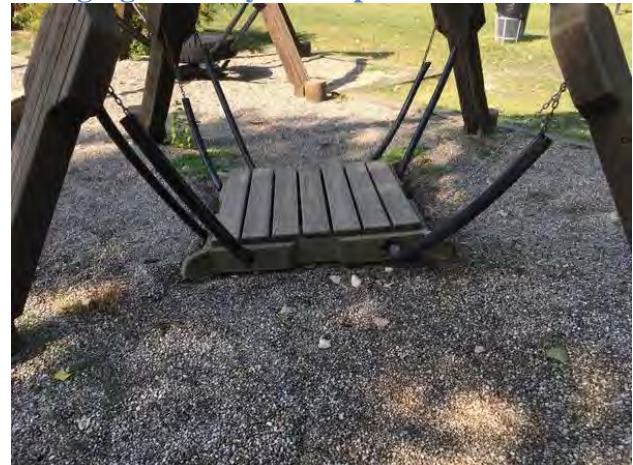
Swinging Floor Pyramid picture #1

### Swinging Floor Pyramid condition

Medium: Some visible damage / deterioration / decay observed. Does not appear to be structural at this time.

Replace with new manufactured Team Swing.

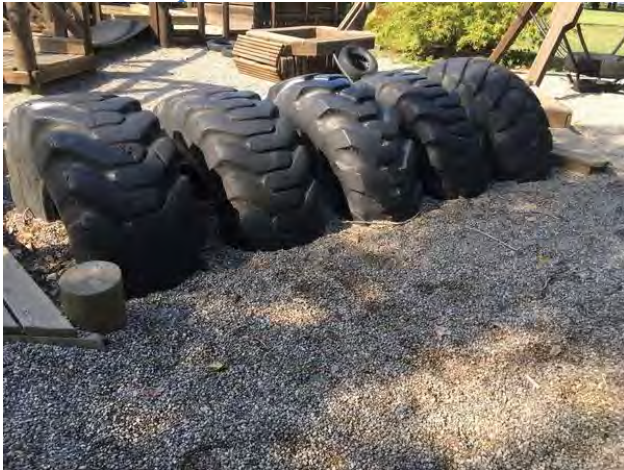
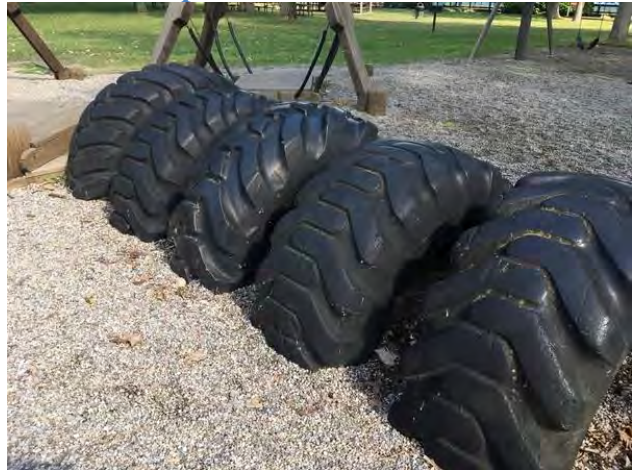
Tire Trench picture #1

### Tire Trench condition

Medium: Some visible damage / deterioration / decay observed. Does not appear to be structural at this time.

The Tire Trench is in good condition.

Repurpose this area with new play equipment.

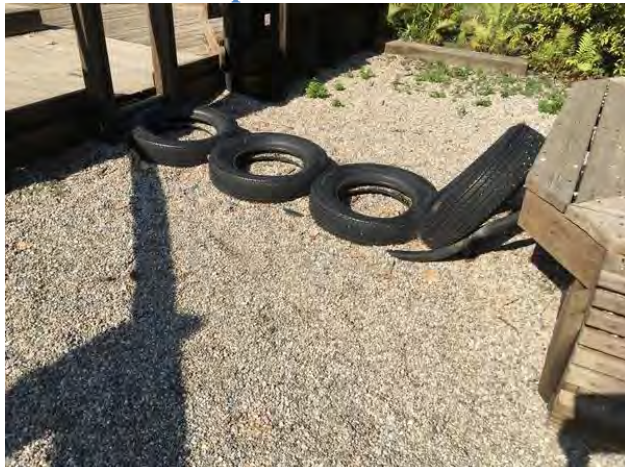
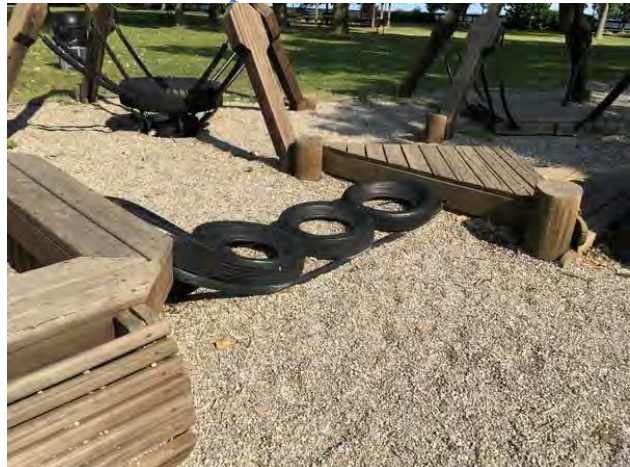
Rabbit Bouncer picture #1

### Rabbit Bouncer condition

Medium: Some visible damage / deterioration / decay observed. Does not appear to be structural at this time.

Repurpose this area with new play equipment.

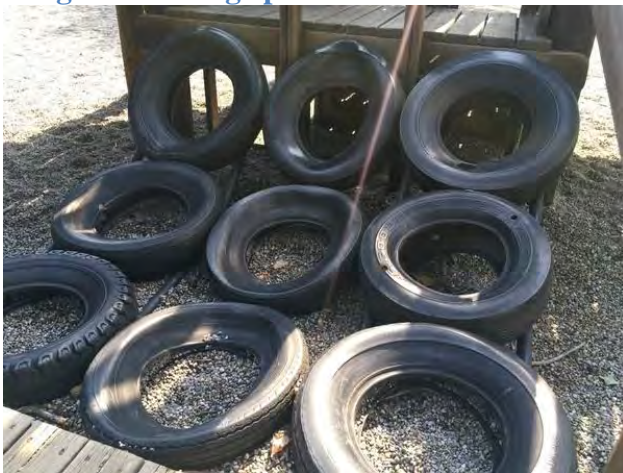
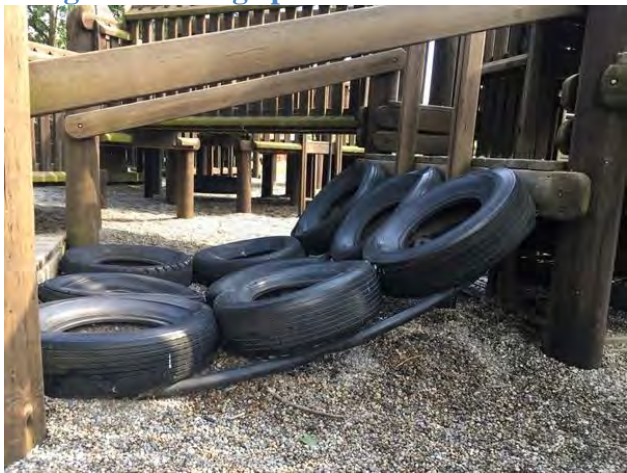
Cargo Tire Bridge picture #1

### Cargo Tire Bridge condition

Medium: Some visible damage / deterioration / decay observed. Does not appear to be structural at this time.

Replace with new cable version. Narrow down opening of deck using similar materials.

Replace with new cable version. Narrow down opening of deck using new plastic lumber.

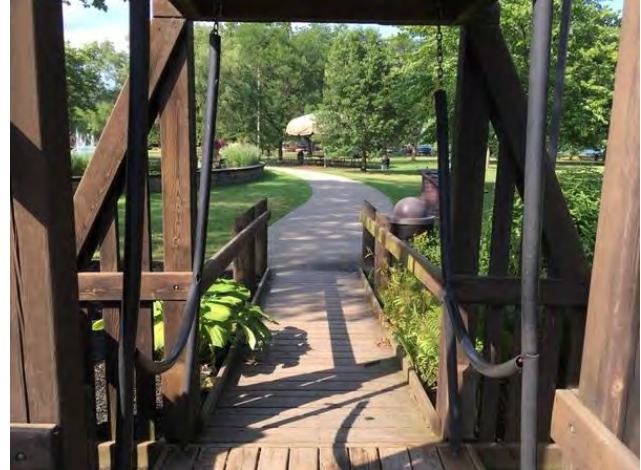
Moving Floor picture #2

### Moving Floor condition

Medium: Some visible damage / deterioration / decay observed. Does not appear to be structural at this time.
